## EXPERIMENTAL DIAGNOSTICS AND STATIC ASSESSMENT OF FIRE DAMAGED STEEL STRUCTURE

**In the paper are presented the results of diagnostics, tests of materials, numerical modelling and static analysis of the current state of the bearing steel structure of the hall after a fire and design of the actions for the repair of the damaged steel structural members.**

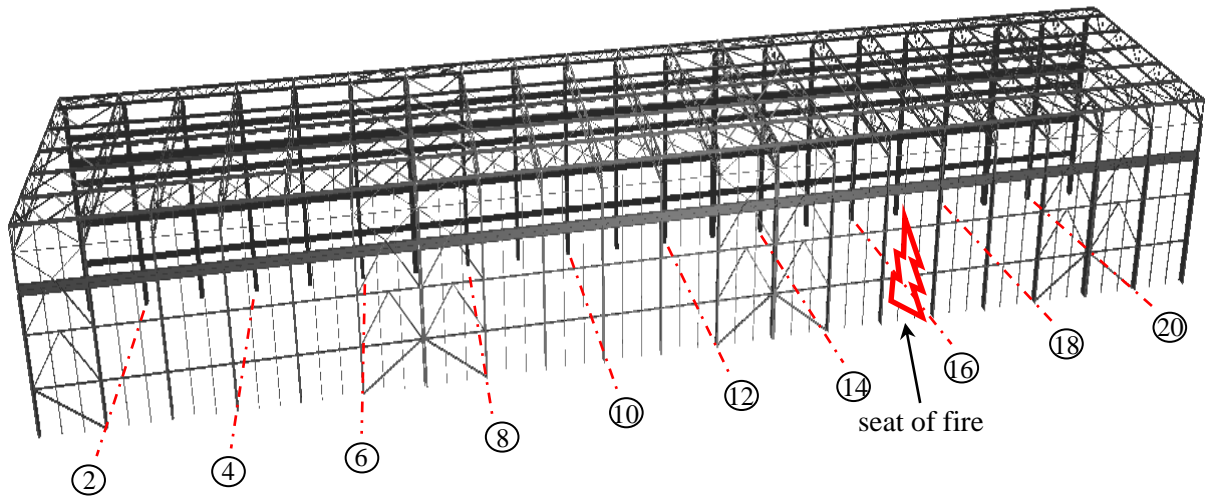
*Fig. 1. Model of the hall with marked axes of the individual transversal bonds and denotation of the seat of fire*

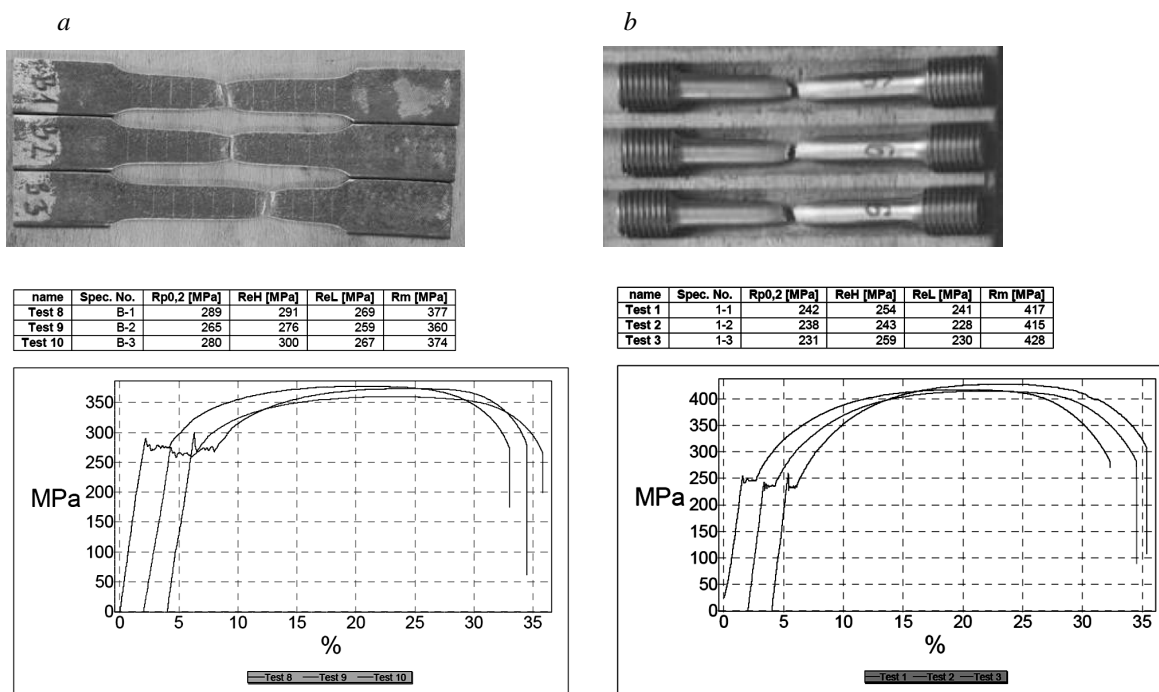
Tensile diagrams correspond to the low carbon structural steel used for welded structures. The fracture appearance corresponds to the mechanical properties evaluated. No anomalies in the behaviour of tested samples were detected.

Fig. 2. Flat testing specimens (a), cylindrical testing specimens (b) and stress-strain diagrams ( $R_{p0,2} \rightarrow f_{y0,2}$ ,  $R_{eH} \rightarrow f_{yU}$ ,  $R_{eL} \rightarrow f_{yL}$ ,  $R_m \rightarrow f_u$ )

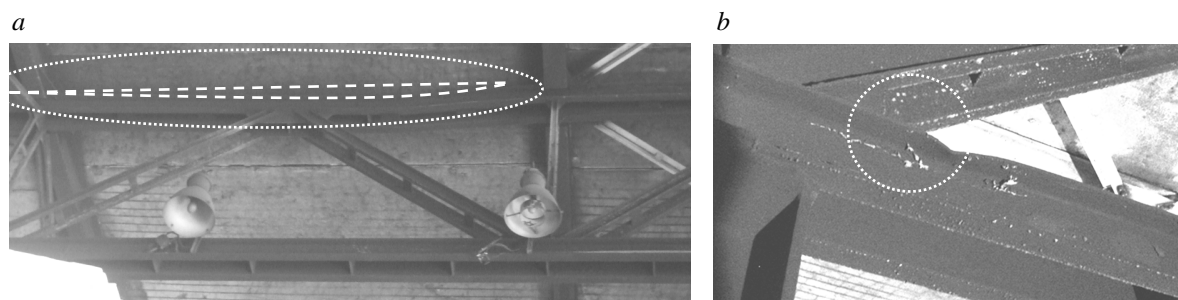
- Plastic deformations of the top chords of truss tie-beams in the 15 and 16 axes and their spatial displacement were identified as is shown in Fig. 3;
- In the bottom chords of truss tie-beams in the 15 and 16 axes local plastic deformations of the cross-sections near supports (at the steel columns) were occurred;
- Web buckling between stiffeners of the column in the 16 axis was identified;
- The main girder of the crane track is not distorted (deflection of the rail axis obtained by measurement is compensated through the necessary rectification);
- Vertical longitudinal roof bracings situated between the truss tie-beams in the 15-16 axes are deformed;
- Side horizontal roof bracings in the roof plane are not deformed.

Fig. 3. a) the deformed buckled top chord of the truss tie-beam in the 16 axis (over the outbreak of fire) b) the deformed bottom chord of the truss tie-beam in the 16 axis (over the outbreak of fire)

- Continuous geodetic measurements of the selected points in the top and bottom chords of roof trusses in the 15 and 16 axes confirmed the progressive increase of the displacements (deformations) in the horizontal transversal direction during the period of the four days. In the place of the buckled chord (truss in the 16 axis) the increment of the displacement in the horizontal direction of approximately 35 mm occurred. In the middle of the bottom chord of the truss in the axis 15 the increment of the displacement in the horizontal direction of approximately 70 mm was measured.

- Strengthening of a locally failed web of the column in the 16 axis by the addition of transversal stiffeners.
- Stabilization and disburdening of the roof truss tie-beams in the 15 and 16 axes by means of the placement of the temporary supporting columns under the purlines in the places between the 14-15, 15-16 and 16-17 axes. A temporary supporting system with the damping members may be situated on the bridge cranes.
- Removing of the roof porous concrete panels between the 14-15, 15-16 and 16-17 axes (replace them by a light-weight sandwich roof cladding).
- Strengthening of the top chords of the trusses.

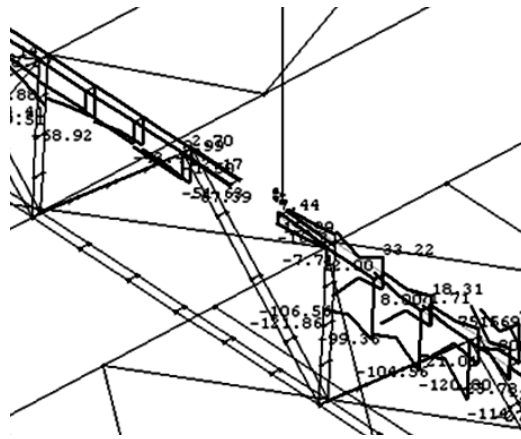
Fig. 7. The resultant distribution of stresses in the top chords of the truss tie-beams

- Current behaviour of the roof trusses in the 15 and 16 axes (an area of the fire) is behind the limits of the allowable stresses and deflections. Consequently, the roof trusses do not fulfil criteria of the reliability defined by the ultimate limit states as well as by the serviceability limit states.
- Columns fulfil conditions of reliability in the case, that the local damaged (buckled) web of the column in the 16 axis will be reinforced.

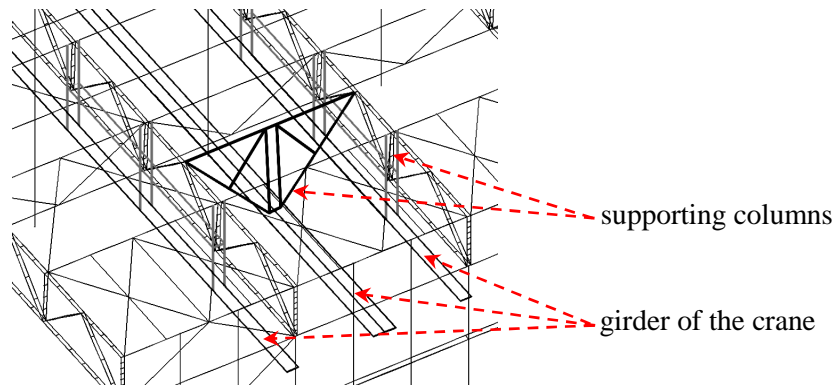
Fig. 8. Scheme of the purlines supporting by the brace struts situated on the girder of the bridge crane

- A temporary supporting system with the brace struts are situated on the bridge cranes of lifting capacities 20 t and 50 t.
- Support the purlines and activate supporting system as is shown in Fig. 8.
- A minimum resistance of each of the brace struts is 70 kN.
- In order to eliminate the influence of vibrations of cranes brace struts are situated on the elastic bases.
- The top chords of the truss tie-beams are in the places of deviations stabilized by brace struts situated in the joints of trusses (Fig. 8). Brace struts are connected to joints of trusses by wells.
- After an implementation of the mentioned measures the necessary strengthening of the top chords of the trusses can be performed (Fig. 9).

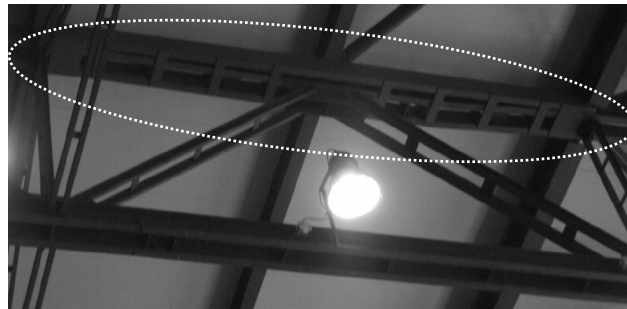
Fig. 9. The strengthened top chord of the truss tie-beam (in the area over the fire)

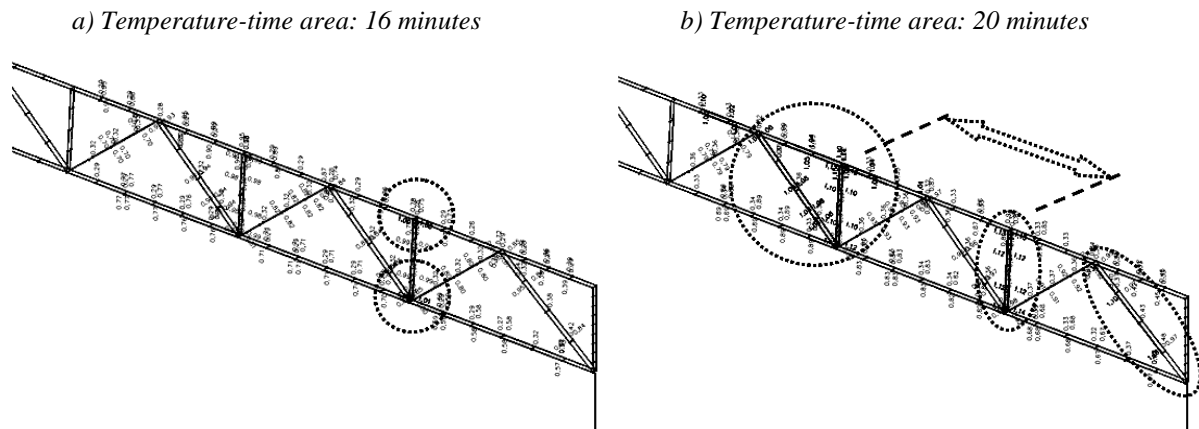
Fig. 12. Assessment of the individual members of the steel truss tie-beam in the temperature-time area with respect to the critical temperature of the material, with the marked members which have reached temperatures higher than the critical temperature, deformation zone is marked (Fig. 3a)

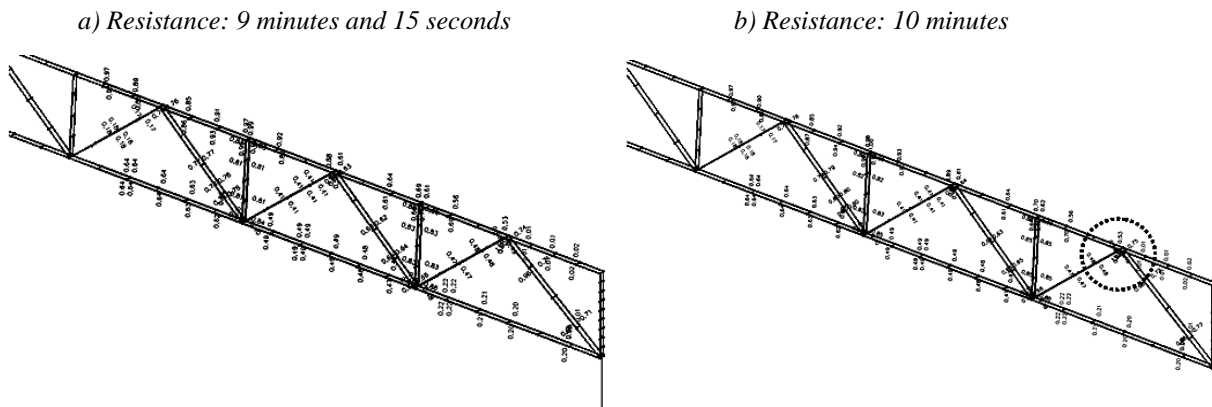
Fig. 13. Resistance of the individual members of the steel truss tie-beam depending on the time, where the members with the unsatisfactory resistance are marked, deformation zone is marked (Fig. 3a)

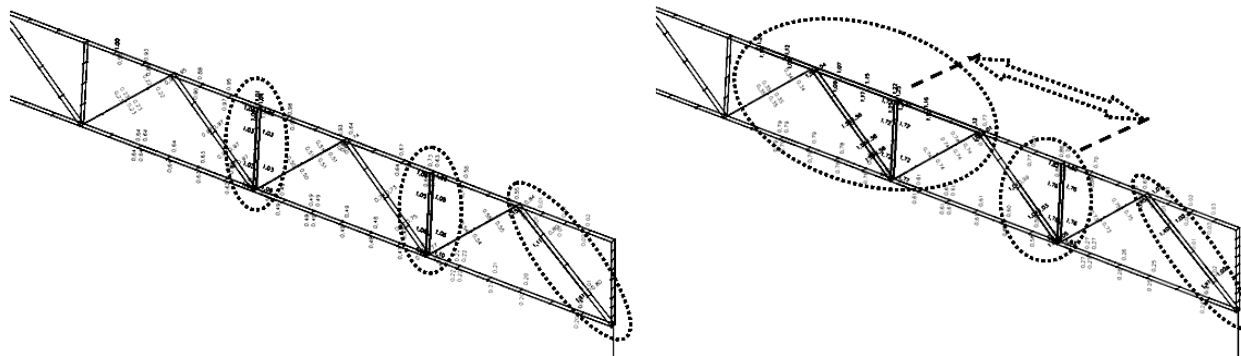
Fig. 14. Resistance of the individual members of the steel truss tie-beam depending on the time, where the members with the unsatisfactory resistance are marked, deformation zone is marked (Fig. 3a)
