FAILURES OF SEWER PIPES MADE OF PVC / УШКОДЖЕННЯ КАНАЛІЗАЦІЙНИХ КАНАЛІВ ВИКОНАНИХ З ПВХ ТРУБ

© *Kuliczowska E., Gierczak M., 2013*

This paper presents the field measurements results of sewer pipes made of PVC, which were newly laid in the ground. The research was carried out applying CCTV (Closed Circuit Television) inspections, which was performed during the construction works acceptance of the sewer pipes some weeks or months after their laying in the ground. More than 11 km of sewers from 11 cities in Poland were analyzed. The analysis was carried out based on the research conducted among other things by Kielce University of Technology. A detailed analysis of specific flexible pipes failures was carried out. Failures, which occurred most frequently and on the highest percentage of the sewer pipe lengths were identified. The failures were classified according to the intensity of their occurrence and caused danger. Class 1 covers the greatest failures and the highest level of danger, class 5 covers minor failures with the lower level of danger. The technical condition of the investigated sewers was assessed by classifying the particular sections to one of 3 groups: G 1 – without

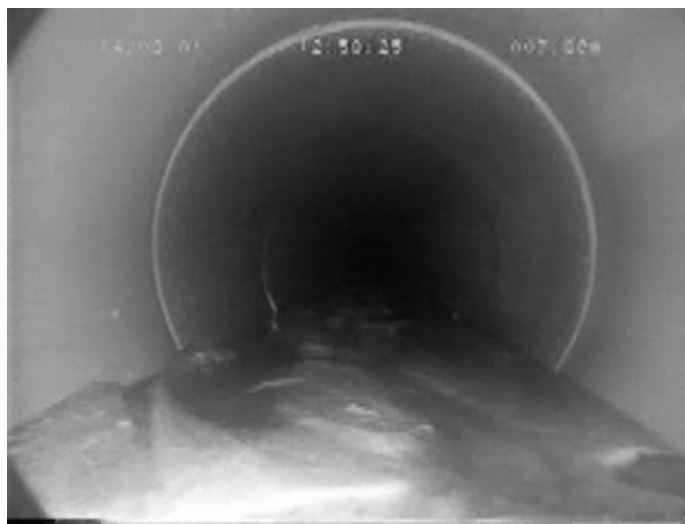
The sediments in the bottom of the sewer, which come from the construction period, were connected in most cases with improper longitudinal gradient of the sewers. More than 80% of those sediments were assigned to 5th class of failures, because they occupied less than 5% of the sewer cross-section. To 4th class there was classified 15.17% of the sewer length which were occupied by the sediments, to 3rd class 1.74%, to 2nd class 0.39%, to 1st class only 0.04% of the sewer length which was occupied by the movable sediment occupying more than 50% of the sewer cross-section. Figure 10 shows the movable sediment, which was classified to 4th class of failures.

Fig. 10. The movable sediment, which was classified to 4th class of failures

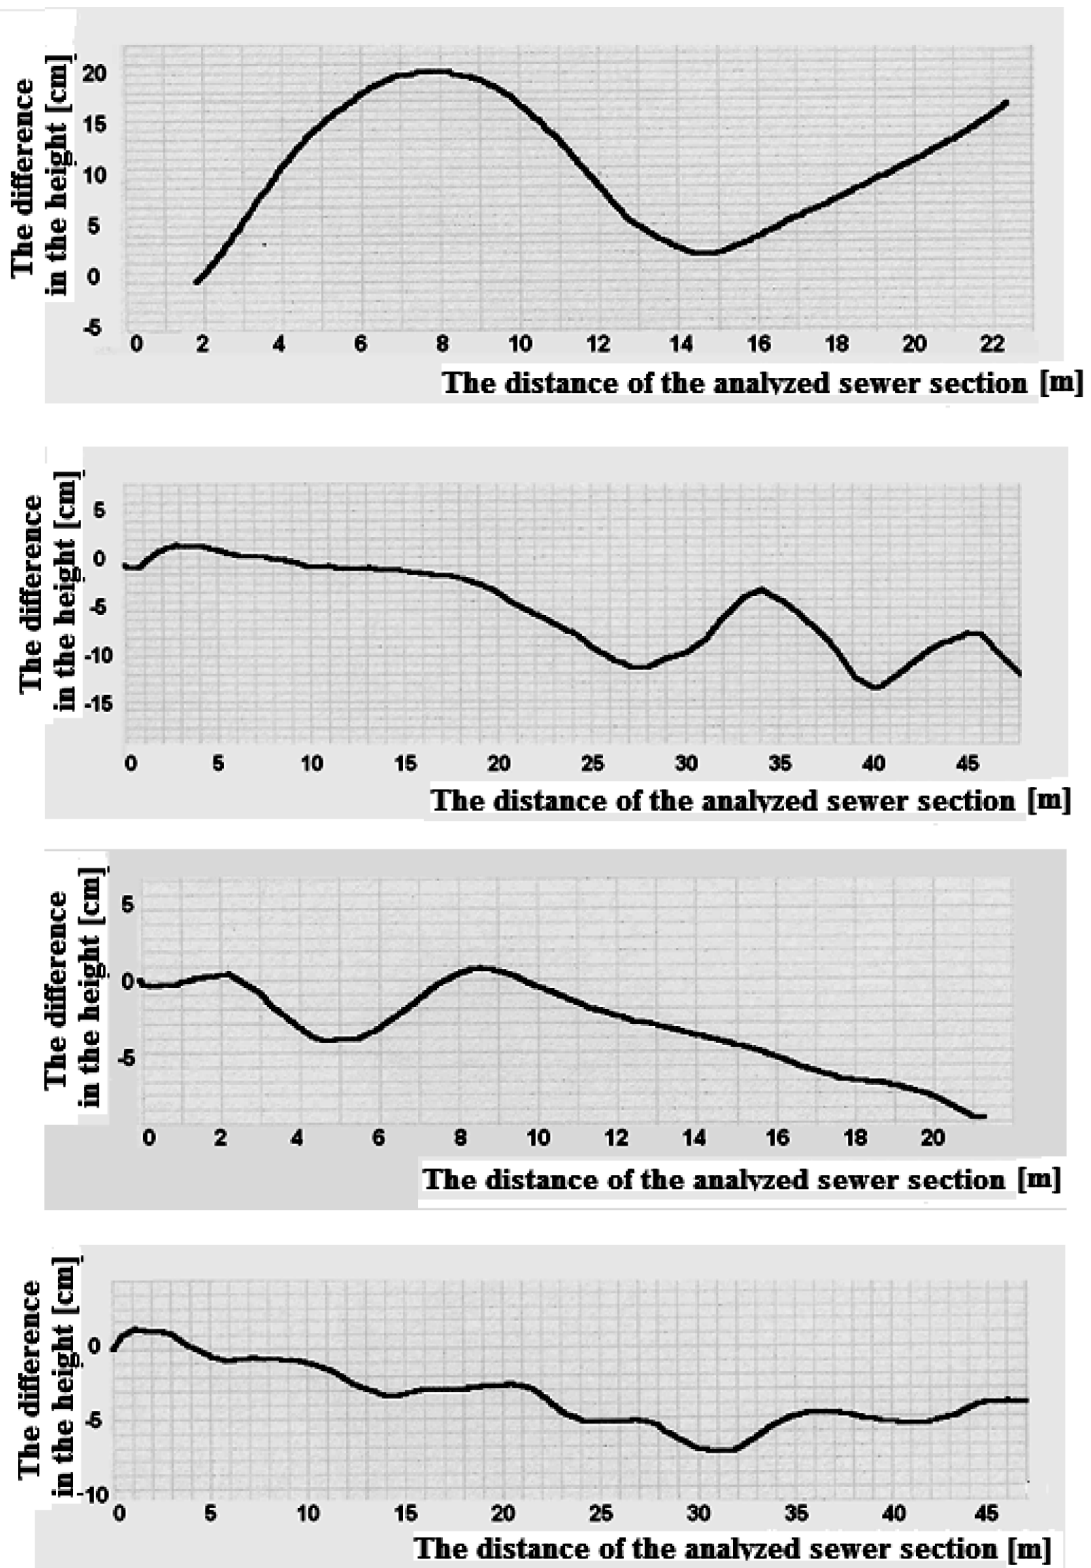
Figure 11 shows four examples of the improper sewer longitudinal gradients. On X-axis there was shown the distance of the analyzed sewer section in [m] measured from the manhole to manhole, on Y-axis the registered difference in the height of the sewer bottom between the particular point on the sewer section and the 1st manhole in [cm].

Fig. 11. Improper longitudinal gradients of the sewers

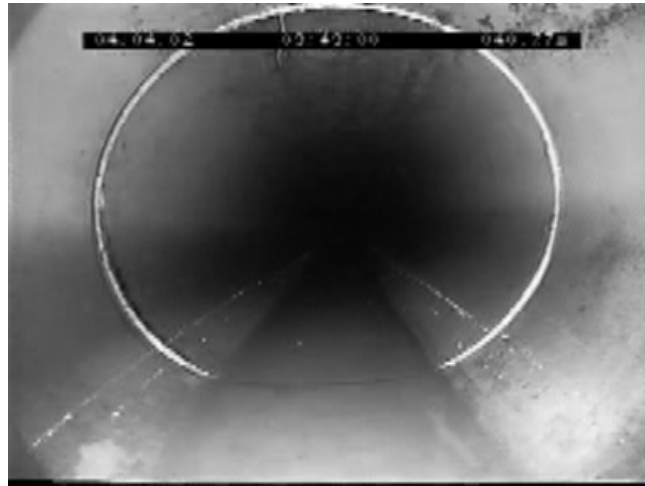
The deflection of the pipe's top was observed on the considerable pipe's length. In 86.6% they were minor deflections, lower than 6%, qualified to 5th class of failures. To 4th class of failures there were classified 13.3% of the deflected pipes, where deflections were more than 6% and less than 15%. According to the proposed classification only 0.1% of the deflected pipes were classified to 3rd class. Their deflection was more than 15%. The deflection of the top of the pipe classified to the 4th class was shown in figure 12.

Fig.12. The deflection of the top of the pipe in the 4th class of failures

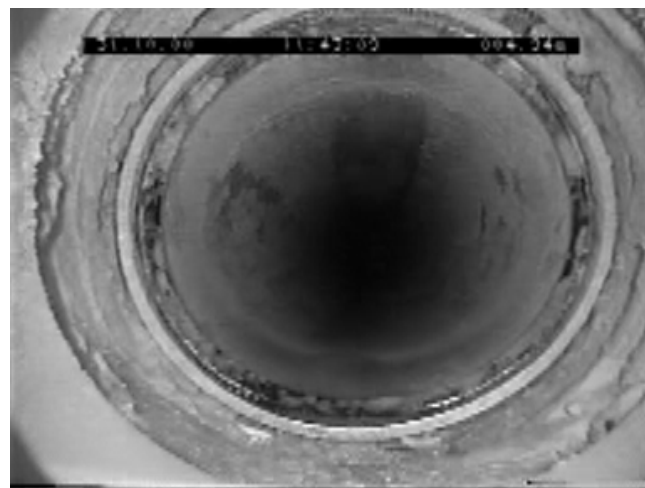
The point failures which were most commonly observed were: longitudinal displacements. The most of the longitudinal displacements (91.7%) was observed in the 5th class of failures. Only in one place (1st class – 0.3%) there was the direct contact of the interior of the pipe with the ground, shown in figure 13. Low one-sided longitudinal displacements (5th class) are shown in figure 14. It indicates the improper longitudinal slope.

Fig. 13. The longitudinal displacement in the 1st class of failures

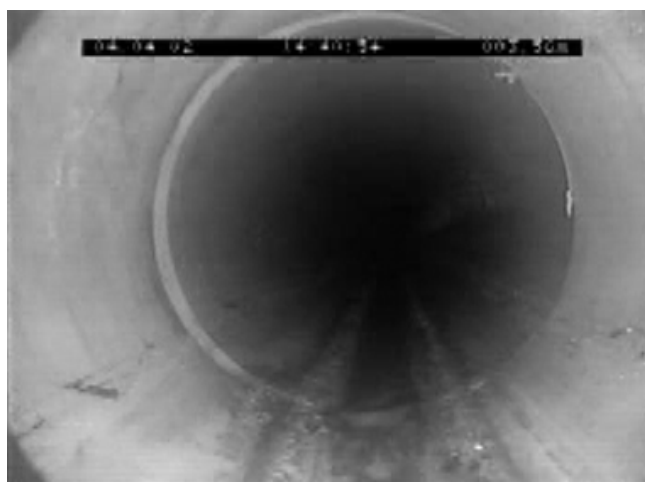
Fig. 14. One sided longitudinal displacement in the 5th class

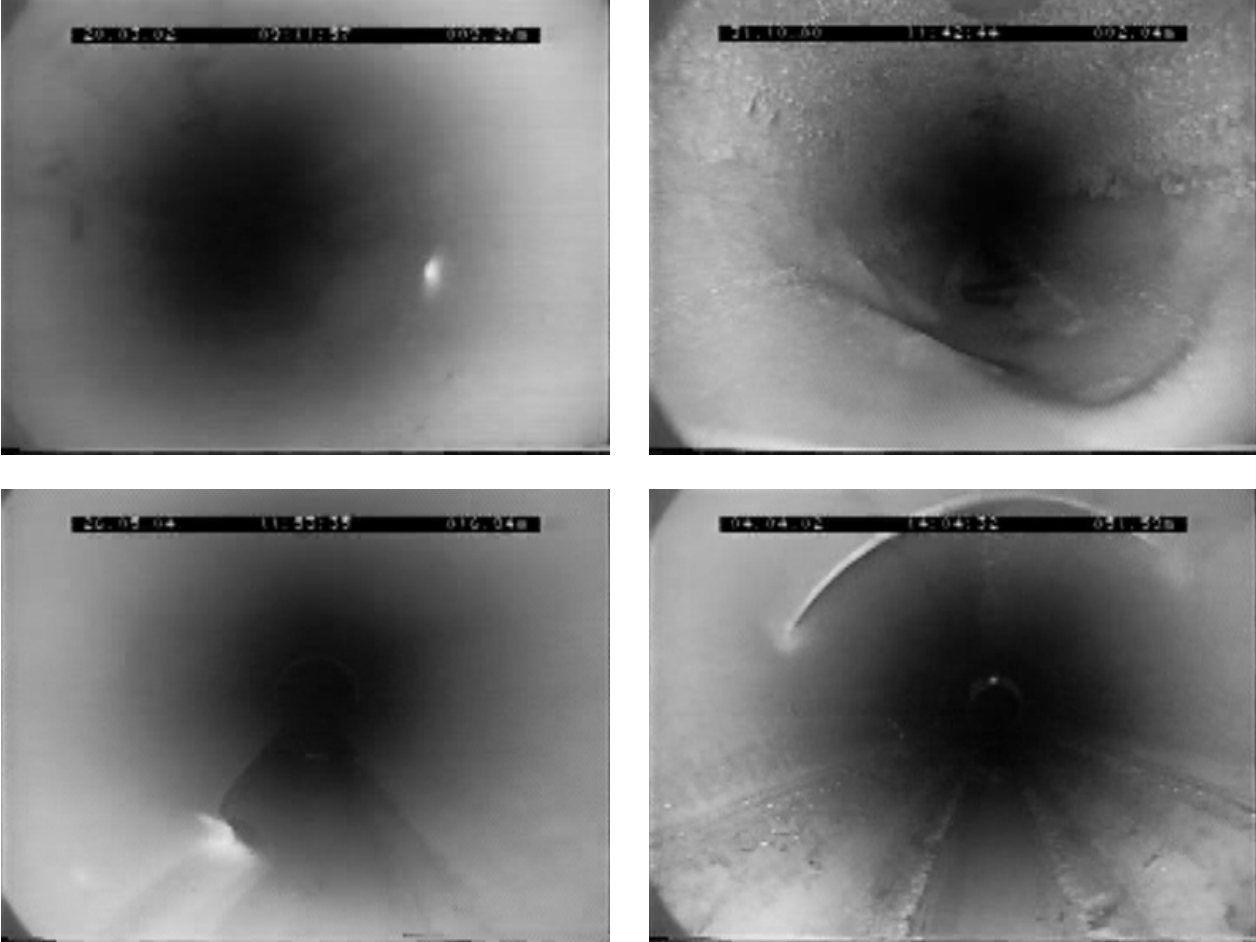
More than half of the observed local dents e.g. from the cobbles were classified to the 4th class of failures. Less of the failures (26.6%) were classified to the 3rd class, much less (16.4%) were classified to the 2nd class. One dent of 1.3% was classified to 1 st class and was larger than 20 mm. The examples of the local dents are shown in figure 15.

Fig. 15. The examples of the local dents of the pipe

The local dents observed in the investigated sewers indicate the careless carrying out the sand bedding and sand backfill of the pipes.

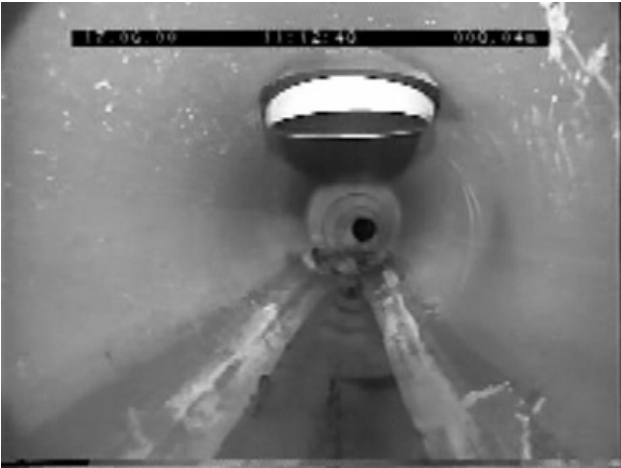
Fig. 16. The house sewer that juts out to the pipe interior

The house drains or the sealing that jut out to the interior in 55.6% occupied less than 5% of the pipe cross section and were classified to the 5th class of failures. 44% of those obstacles in the flow were classified to the 4th class, as they occupied more than 5% but less than 20% of the pipe interior. In figure 16 there is shown the house drain that juts out to the pipe's interior and unables the progress of the camera. In figure 17 there is shown the sealing which juts out of the connection.

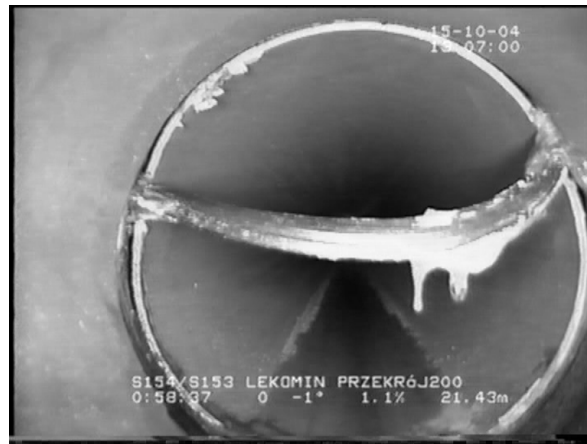
Fig. 17. The sealing that juts out from the place of pipe connection to the pipe interior
