Roof over PGE Arena in Gdansk. Review of structure and monitoring system

Żóltowski K., Romaszkievicz T., M.Sc. Eng.

Technical University of Gdansk, Poland

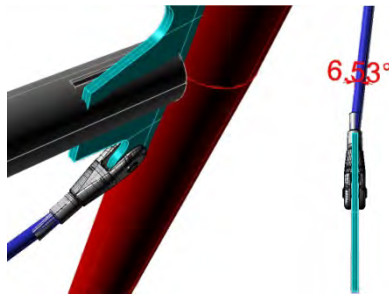
The shape distortion of the horizontal tubes in the supporting nodes forced change in tolerance of the cast bearing parts. The already manufactured elements had to be ground. More significant were the geometric deviations in the position of the gusset plates in the few first girders (Fig. 10). They caused imperfections in the connection of the circumference tubes and bracings to the node, which exceeded the allowed values. The contractor in consultation with the designer and investor managed to repair the positioning of the plates basing on prof. Edmund Tasak's method [5]. The method involved: partial incision of the plates, thermal straightening and welding. An important element of the process was a nonlinear analysis of a detail with a plate deformed by straightening [6]. For this purpose several shell MES models, including various degree of geometric imperfection, were made. One of them is shown in figure 11.

Fig. 10. Visualisation of an improper placing of plates

The numerical analysis revealed strength reserves of steel in the deformed node, which allowed to accept the procedure of repairing. After revealing the imperfection in the few first girders, it was eliminated in the next ones.

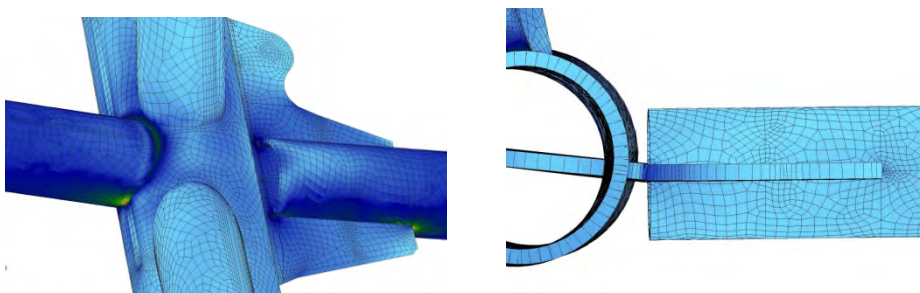
Fig. 11. Visualisation of the analysed node with a deformed plate

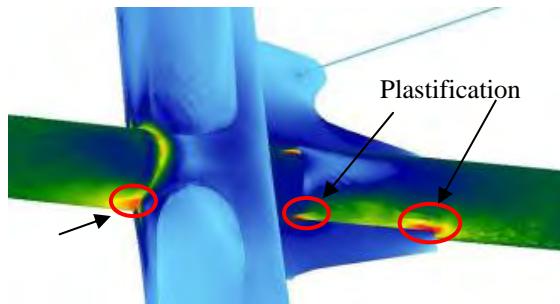
Fig. 12. Visualisation of the node with marked places where steel exceeds the yield strength

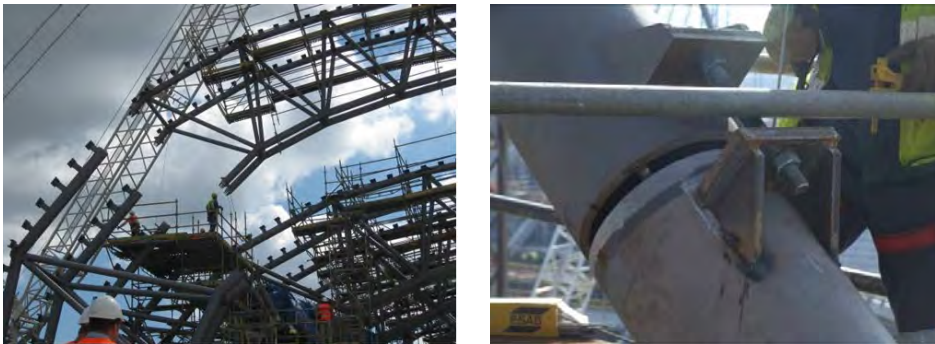
The next problem appeared while fitting the connecting roof part of the girder to the façade part. It was hard for the contractor to connect the two parts precisely in the four points keeping the whole girder in the correct position. In the few first girders, the gap between the two parts of one tube was too big (Fig. 13). Tightening was very easy by regulation of the free end of the girder but in this case it was absolutely forbidden, because of the additional internal stress in the range of 200 MPa. In that case the contractor had to cut off about 700 mm of the tube and insert a new fitted piece. After that the positioning procedures were upgraded and the problem was solved.

Fig. 13. The connection process of the girder roof part with the façade part

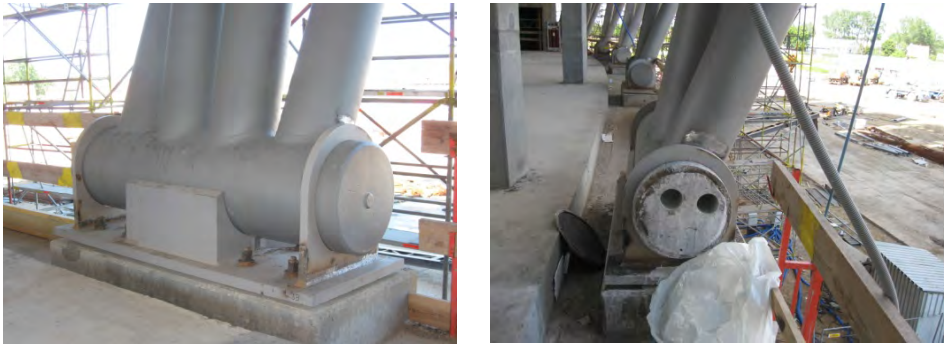
1. shape distortion of the horizontal tube in the supporting node as a result of welding (detail shown on Fig. 14),
2. geometric deviations in gusset plates,

3. accuracy problems in the lengths of the tube members accrued while fitting the facade and the roof part of the girder,
4. problems with quality of filled concrete in the horizontal tube (supporting node).

An expected problem occurred with the support node filled with concrete (Fig. 14). The support detail was designed as a hinge in the erection stages. The final shape was created by a steel designer to fulfil aesthetic aspects. The main element of the seating part designed as welded was finally manufactured as cast

steel (decision of the contractor). The horizontal tube was filled with concrete to increase its bearing capacity. The inspection of this concrete showed that its parameters do not correspond to the design assumptions (B-28 instead of B-50). The replacement of the concrete filling was difficult due to the already erected structure and timetable. Therefore, there was decided to analyze the carrying capacity of the support node with actual quality of concrete. For this purpose, a laboratory test was done on the model in scale 1:1 at Gdansk University of Technology. The support piece was filled with concrete ~B28 (Fig. 16). The laboratory test was designed on the base of numeric FEM model shown in figure 15.

Fig. 14. Support of the girder and the place where the samples were taken

The maximum normal force in the vertical tube of the support node was estimated as 2500 kN. During the tests a load of ~5000 kN was reached (the limit of the hydraulic press) without a serious symptom of overloading. This could happen thanks to the change of the seating part of the bearing form, welded to the cast (contact area increased radically). On the base of the laboratory test the existing concrete filling was accepted.

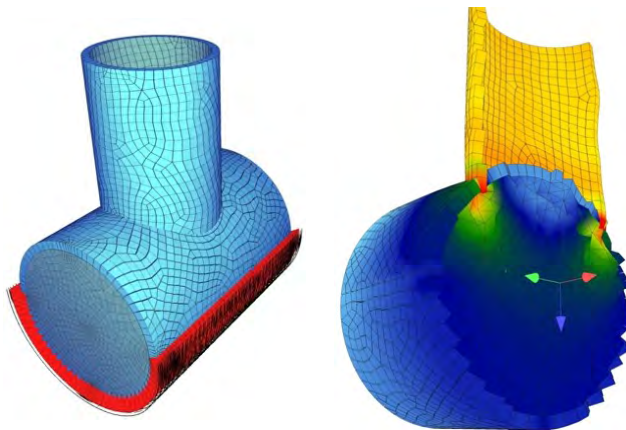
Fig. 15. FEA model of the support and stress concentration

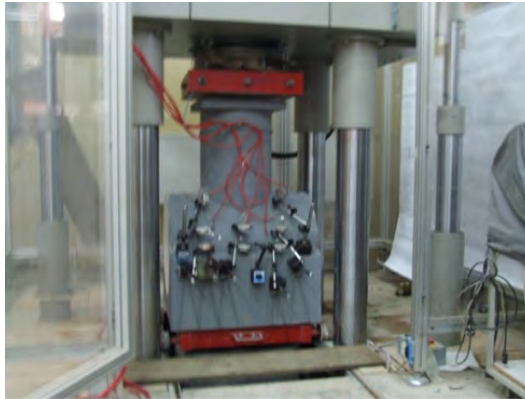
Fig. 16. Laboratory tests of a real scale model
