BADIDA Miroslav, Dr.h.c. prof. Ing., PhD.

UTILIZATION INFRARED THERMOGRAPHY IN THE AUTOMOTIVE INDUSTRY TO DETERMINE FAULTS BY USING THERMAL CAMERA FLUKE Ti10

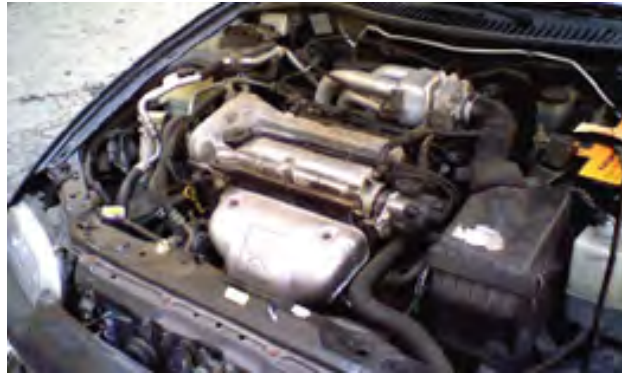
Fig. 6 Visible light image [3]

In the evaluation, we focused mainly on the image of fully warm engine, on which were clearly visible deficiencies. It was mainly a thermal anomaly in exhaust pipe area on 4. cylinder (Fig. 6). Due to the fact that the engine in the emission test showed increased emissions and noise from the exhaust pipe, we concluded that the problem is just the fourth cylinder on the basis of exhaust pipe infrared images, which showed a lower temperature compared to the other three pipelines under the heat shield (Fig. 7).

Subsequently, the test moved to diagnose spark plugs and distributor. The problem arised in this area, because the primary and secondary winding of distribution coil was off the manufacturer's specified values, resulting in a poor running engine and low power, but the problem that caused the bad combustion process on the 4th cylinder was the head of the distributor with damaged pin for power supply to the ignition cable and spark plug. After replacing these parts and reset of the engine control unit, this error did not repeat, and the engine has not only improved performance, but also emission rates and combustion temperatures. [5, 9, 11]

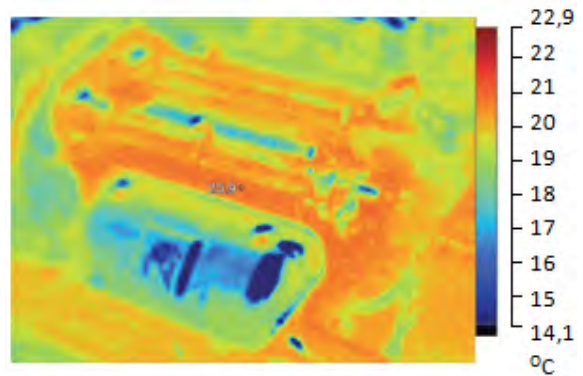
Fig. 7 IR-fusion.IS2 [3]

There have been two options for cooler pipe on 4. cylinder - a bad fuel injector, or bad fuel ignition. Therefore, testing of the ramp injections took place through injection nozzles and its seals because of the possible fuel leaks, or due to clogging of injection nozzles. Problem was not confirmed at this point. The next step was to test the engine compression without combustion process and engine oil analysis for the presence of fuel. Compression was standard, as specified by the manufacturer of internal combustion engine, but the oil showed a small representation of unburned gasoline. This test was done by a authorized service. [4]
