STRESS-STRAIN STATE OF BEAM STAGED CONNECTION POINT OF THE RAILWAY BRIDGE TRACK-WAY

The work was performed by the Sectoral Scientific Research Laboratory (SSRL) of Artificial Structures of the Dnepropetrovsk National University of Railway Transport named after academician V. Lazaryan on the railway bridge over the Mokraya Moskovka River on 186 km of the Krivoy Rog-Volnovaha line.

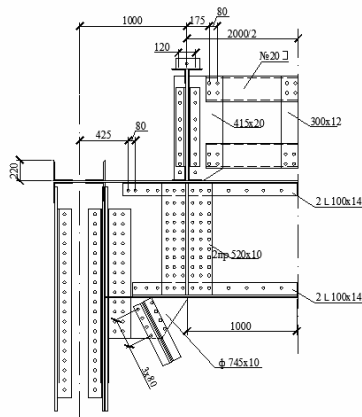
Fig. 1. Construction of beam grid in PSK deck span structures

The staged connections of the beams of railway bridge track-way have the simplest design, but some design flaws result in numerous defects. In the conditions of a staged connection of the track-way beams, because of the large eccentricity between the axes of the stringers and floor beams, the operation of the floor beams and the support unit components is considerably complicated, and there occur local overstress and cracks in the beam flange angles. Stitch rivets (or bolts) joining the

stringers to the floor beams also operate under severe conditions.

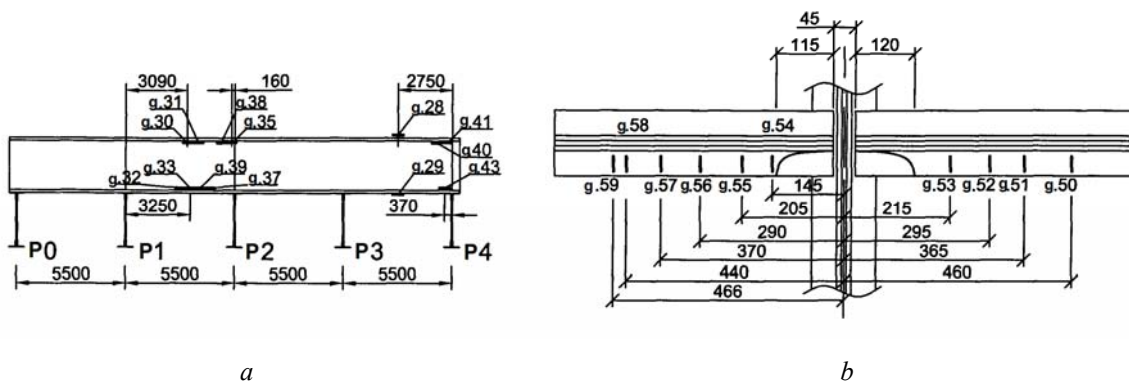
Fig. 3. Arrangement of strain gauges: on the stringer B1;

In the stringer B1, the maximum stresses were recorded in the middle of panel 1-2 and amounted to -35.5 MPa at point 30 (pattern 6) and +19.7 MPa at point 33 (pattern 7) (see Fig. 3 and Fig. 5).

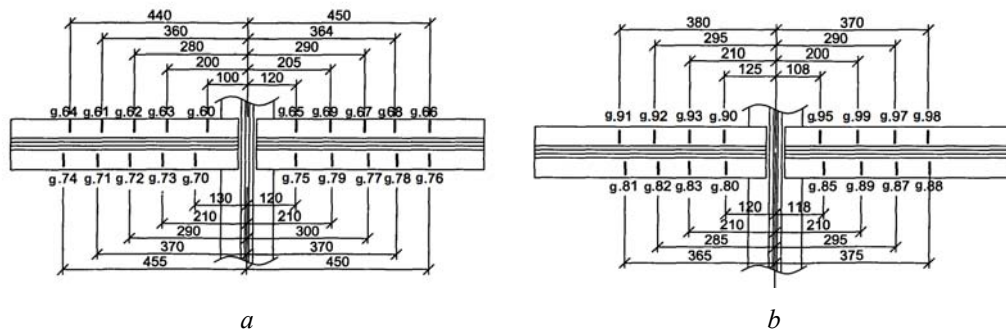
Fig. 4 Arrangement of strain gauges: on the left B1 and right B2 stringers at the point of support on the floor beam P4:

In those places where the cracks have already appeared it was not possible to measure the stresses. The measurements were taken mainly at the points of support of the stringers on the floor beam P4, where cracks in the bottom flange angles of the stringers were not observed during inspection. In these places, a detailed study of the stress state was carried out. The strain gauges were pasted at 32 points on the fillets at the ends of the bottom flange angles on both sides of each stringer every 80–100 mm.

Stresses in the angles proved to be very high (up to 136.4 MPa). It should be noted that the connection of stringers with a floor beam P4, obviously, is not the most stressful point, because in this place, instead of the stringer bottom angle fish-plates there are extended gusset plates for break connections. This is particularly significant as the design of the span structures did not include the checks of the stresses in these places. In other connections, where cracks are already observed in the angles the stresses appeared to be even higher.

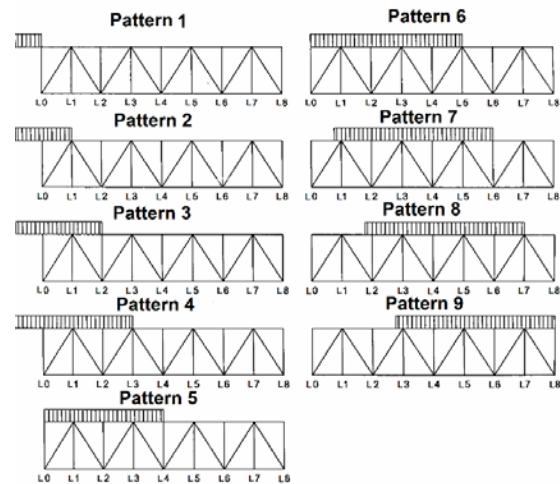
Fig. 5. Test loading patterns for span 0–1

For the end floor beam P0, which is the most intensively involved in joint work with the truss booms, an unfavorable test load setting became the loading according to pattern 6.

In this case the greatest stresses in the flange angles reached +49.5 (p. 2) MPa and –63.7 MPa (p. 1). The stress state of the floor beam P0 for various loading patterns is given in Table 1.
