*Bohdan Cherkes, Violetta Radomska*

**CURRENT STATE OF PRESERVATION  
AND PROBLEMATICS OF RESTORING POLYCHROME  
PAINTINGS BY MODEST SOSENKO IN THE STRUCTURE  
OF SACRED ARCHITECTURE**

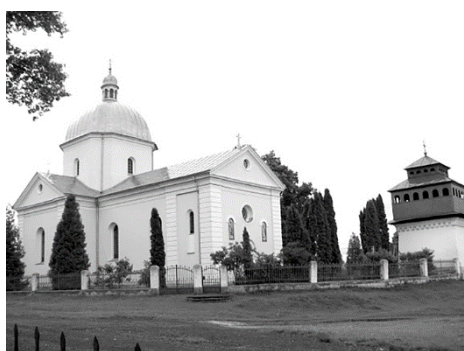
**Fig. 1.** Arch. Michael Church, Pidberiztsi (a); Fragment of mural by M. Sosenko (1907) on the apse top (b); photo by A. Tyrpych, 1996

The construction of Archangel Michael Church in Pidberiztsi, Pustomyty district, Lviv region (architect V. Nahirnyi) was finished in 1891. Modest Sosenko executed organization of the interior space in 1907–1910 actively collaborating with the firm of I. Levynskyi as a stylist and decorator, icon painter, designer of stained-glass windows and iconostases.

This is a brick crossed-dome temple, which has a two-armed cross with a longer descending part (nave, narthex) and an octagonal drum of a dome at the transept crossing (four main sides are smaller), which is crowned by a lantern with an onion dome. The eastern part of the temple has a rounded apse with a hemispheric top (Fig. 1). The architectural space of the temple is divided in accordance with the basic functions of a temple of the byzantine rite. The temple interior is the expression of harmony and interconnection between the architectural and constructive intention of the architect and the stylistic organization of the sacred space (Fig. 1–3). At the first glance, the preservation state of the authentic polychrome paintings by Modest Sosenko is satisfactory. However, as those of 2019, the material structure of the paint layers is exposed to serious deterioration processes. In 1980s, the group of professional restoration artists under the supervision of N. Prysiazhna performed the reinforcement test of the powdering pigment of authentic polychrome paintings and cleaned the surface contamination that partially distorted the original coloristic patterns (last eastern pilaster of the nave). However, restoration works were stopped due to the lack of funds. During mechanical interventions, the powdering nature of pigment causes its loss and gradual peeling from the wall. Such mechanical damage ruins the elegance and integrity of a colorful compositional image of a painting and causes its elimination with the help of faster and less pricy procedures, as it happened with the repainting of transept niches back in 2008. One of the priorities of the further monument preservation is to discontinue the practice of fragmentary renewals that occur in the structure of polychrome paintings (authentic inscription above the narthex, repeated oil-based coats of panels in the nave). The availability of multiple oil-based coats led to the cease of ventilation of walls and plaster. The condensed moisture in the brick laying and the lime and sand plaster resulted in accumulation and reproduction of microbes, appearance of salt efflorescence, etc., and, consequently, its detachment from the walls and powdering. In July 2008, “Restoration practice” (restoration artist V. Radomska) was organized and its primary objective was: – to uncover the original polychrome paintings by M. Sosenko located in the northern and southern niches of transept from the re-paintings made in 1970s and 2008; – to cease the subsequent unprofessional restoration interventions; – to develop and test in practice the program of the subsequent comprehensive restoration of this unique monument

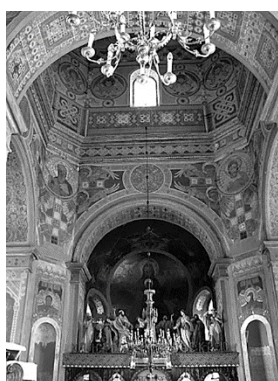
c

**Fig. 2.** Polychrome painting, central dome of transept (c); Layout of Arch. Michael Church, Pidberiztsi performed by A. Tyrpych (c1), 2015

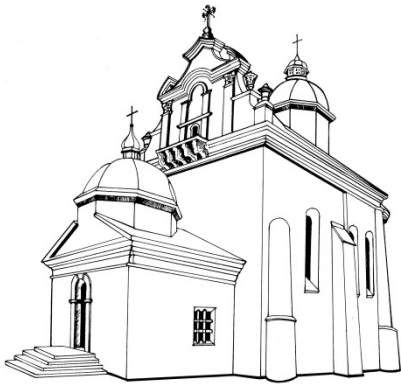
**Fig. 4.** St. Nicholas Church, Zolochiv, graphics by A. Tyrpych, 2015

St. Nicholas Church in Zolochiv, Lviv region, is the architectural monument of the XVIth century, which back in the past used to be a part of the defensive constructions of Zolochiv in Hlynianske suburb. The defensive features of St. Nicholas Church are preserved nowadays and include thickness of walls, window apertures, fittings, etc. The construction started in the XVIth century and finished in the early XVIIth century; its founder is Mykola Vasyl Pototskyi; the church was restored in 1765; the sculptor of the stone plastic arts on the church facade is Frantsisk Olenskyi; the author of polychrome paintings of 1911–1913 is Modest Sosenko (Hupalo, 2007, p. 12–15). The inscription states that back in 1911–1913 the interior space of the church, namely murals, was fully reconstructed and restored. The task was assigned to Modest Sosenko, who created the new conception of decorating spatial composition of church interior with the help of polychrome paintings and followed the traditional for him idea of combining Neo-

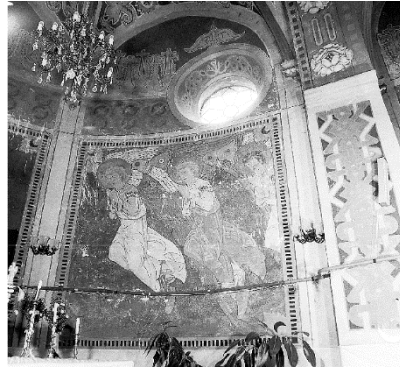
**Fig. 5.** Polychrome paintings by M. Sosenko (1911–1913), photo by V. Radomska, 1991

Byzantine stylistics and modernist aesthetics. In 1940s, during the Soviet period, St. Nicholas Church housed the museum of atheism. The iconostasis was dismantled; the icons and the elements of carvings and plastic arts were sent to Lviv National Museum named after A. Sheptytskyi, Museum of History of Religion and Lviv Art Gallery. In 1990, when Greek Catholic church was legalized, the building was transferred to serve the liturgical needs of Zolochiv Basilian Monastery. In 1991, scientific expedition (V. Radomska) was organized and its objective was to examine the monuments of architecture with murals and iconostases by Modest Sosenko. It helped to record the real state of polychrome painting preservation as of the moment of changing the functional purpose of the interior space (Fig. 5). In general, the expedition noted the satisfactory and integral state of mural preservation, which could enable the possibility of carrying out the professional conservation and restoration works. Murals in the sanctuary part of the church are preserved most fully, because it used to be the staff area for the museum workers. Repeated changes and renewals are spotted at the narthex top and walls. The reasons for this are the waterproof defects in the roof cladding and the mental habit of “renewing” the entrance transit zones in public buildings. The original name inscriptions on the northern and southern supporting walls of the nave and the narthex were partially covered because the content and the mentioned personalities were “hostile” to the Soviet ideology. As of the spring of 1991, the conclusions of the scientific and restoration expert evaluation outlined the following problems: general powdering of the polychrome painting structure (loss of binding media) and weakening of its connection with the plaster base; cracking, detachment of layers and peeling of plaster; significant surface contamination of the structure of paint layers; salt efflorescence in the structure of plaster and painting; repainting of certain fragments of art work; partial peeling and mechanical damage of paint layers.

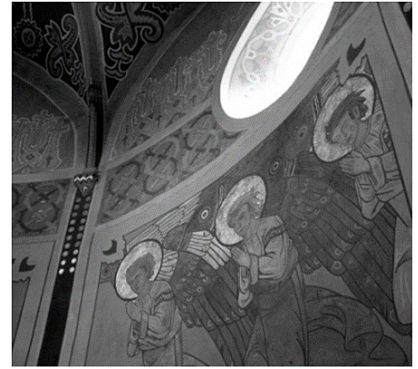
**Fig. 6.** Polychrome paintings by M. Sosenko (1911–1913), photo by A. Tyrpych, 2013

In 2013, the next expedition (restoration artist V. Radomska) was organized and it detected the following changes in the interior space of the architectural monument: – the reconstruction of iconostasis was carried out with the serious changes in stylistics and iconographic content; – the conducted restoration works caused the significant losses in the original coloristic patterns and the texture of polychrome paintings.

The capital repair of the building was conducted in 2000 by efforts of Father Hegumen Volodymyr Palchynskyi. Following the initiative of Father Vasyl Tuchapets, Hegumen of the Basilian monastery, the group of specialists from the Lviv branch office of National Scientific and Research Restoration Center in Ukraine restored the wall murals painted by Modest Sosenko (Utkovych, 2008, p. 130–135). Restoration was executed using the method of preserving the patterns and compositional structure of the original intention of Modest Sosenko. It included integral repainting of an area and partial replication in accordance with the author’s painting and coloristic patterns. The technique of restoration toning in the areas of original painting loss was not detected (Fig. 6). Macro photofixation used in the process of examining the polychrome paintings has outlined the significant differences between the original and the “renewed” coloristic patterns. The subtle texture of glue paintings by Modest Sosenko was leveled down and became monolithic and dumb. The date of “restoration” is recorded at the memorial inscription, located at the supporting northern wall of the nave and the narthex. Later in 2001–2003, the iconostasis was restored by efforts of Father Hegumen Klymentii Stasiv. The external architectonics of the church has also changed. In the past, the lower part of the building socle and the buttress used to have the bare brick texture of the calcareous rock. However, as of 2014, the stone foundation was covered with plaster, most probably without the preliminary correction of the horizontal waterproof system. It affected plaster and caused the increase of humidity in the lower part of foundation and walls. Macro photofixation revealed the tendency of the selective monument preservation, as the earliest architectural details and limestone sculptures made by F. Olenskyi are undergoing the process of gradual deterioration. In general, the object is hypothetically preserved, even though the authenticity of the elegant coloristic patterns and the specific texture that belong to the characteristic technical and technological features of polychrome paintings by Modest Sosenko are irreversibly lost.

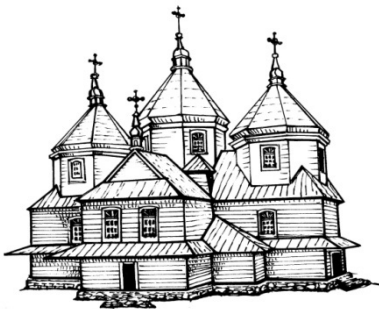
**Fig. 7.** Church of Resurrection of Christ, Polyany, graphics by A. Tyrpych, 2015

Church of Resurrection of Christ, located in Polyany village (Rykiv village till 1946), Zolochiv district, Lviv region, was designed by the architect V. Nahirnyi and dates back to 1903. In 1913–1914, Modest Sosenko created icons for the iconostasis and the two side altars and painted the central dome of the nave (Fig. 7–9).

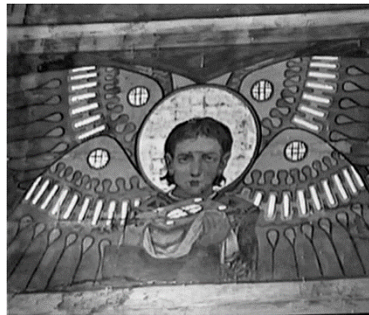
**Fig. 8.** Polychrome paintings by M. Sosenko (1913–1914), photo by A. Tyrpych, 1991

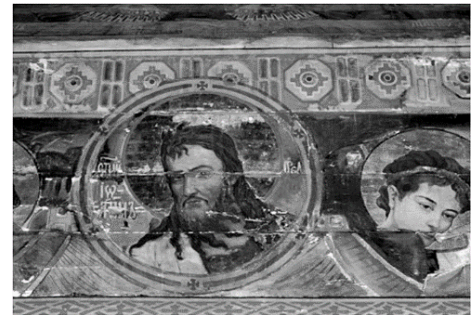
**Fig. 9.** Polychrome paintings by M. Sosenko (1913–1914), photo by A. Tyrpych, 2015

During the expeditions aimed to evaluate the preservation state of the monument of architecture (V. Radomska, 1991, 1996, 2016), we have noticed the gradual self-deterioration of Modest Sosenko polychrome paintings, located at the junctions of wooden constructions under the central dome space (Fig. 9). Partial detachment of linen canvas at the junctions of wooden boards resulted in the peeling of levkas and paint layers of the polychrome paintings. The situation was worsened by the unsatisfactory waterproof characteristics of the church roof cladding. The unstable temperature and humidity regime triggered the deterioration of joints between wooden boards and the appearance of fungi spores, etc. (Fig. 9). It should be pointed out that in 2018 the region council allocated funds to cover the central dome of the church, which could significantly influence the preservation of polychrome (elected official M. Babinska). Currently, those unique murals that are still preserved in their authentic form require urgent attention of experienced and professional restoration artists who specialize in the area of preserving decorative and monumental art objects, located in the structure of an architectural building. The program of restoration works should be based on the idea of preserving original texture, coloristic patterns, and technical and technological peculiarities. It should prevent the unprofessional approach and the “renewal” experience observed in St. Nicholas Church in Zolochiv. The
