## The synagogue in Zhovkva: history and architectural development

Boyko O.

Institute “Ukrzakhidproektrestavratsiya”, 3a Soborna St., Lviv, Ukraine,  
e-mail: ustok@ukr.net

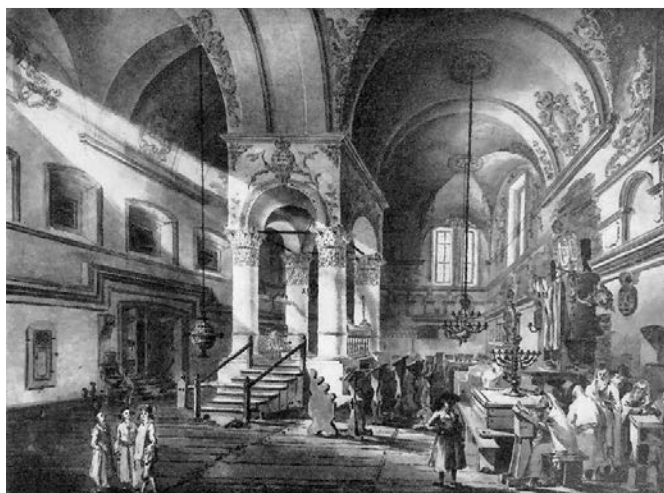
**Fig. 1.** Interior of Łańcut synagogue (1761) as it appears in the drawing by Zygmund Vogel (1797). Jakób Schall has put this image into his book, with the following caption: “*The interior of Zhovkva synagogue before its reconstruction (in the early 19th century), according to the image by Kokulyus*” [www.pinakoteka.zascianer.pl/Vogel](http://www.pinakoteka.zascianer.pl/Vogel)

The impetus for this study has been a drawing of interior of the synagogue published by Schall in his work mentioned above, which has had the following signature: “Interior of the Zhovkva synagogue before its reconstruction (in the early 19th century), according to the image (podług obrazu) by Kokulus” [2] (see Fig. 1). Schall has somehow attributed the authorship of this drawing to a certain ‘Kokulus’. However, all the searches for a name ‘Kokulus’ in different sources from the 19th century have failed. If one goes to the heart of this last name, then the only consistent name found has been ‘Kokuliar’, although he worked as a professor at the Warsaw Academy in the first half of the 19th century. As a matter of fact, the author of the drawing was Polish painter Zygmund Vogel. The drawing has been made in 1797, and it shows the interior of the Łańcut synagogue built in 1761, rather than that of the Zhovkva one. The spatial organization of the synagogue’s architecture depicted in the drawing is completely different than that of the present Zhovkva synagogue. A bema that represents a focus of the author’s intention is not simply a cathedra standing alone among four columns, but an architectural element integrated into a space of the prayer hall. Here the bema is a structural element, which serves as a support in the form of

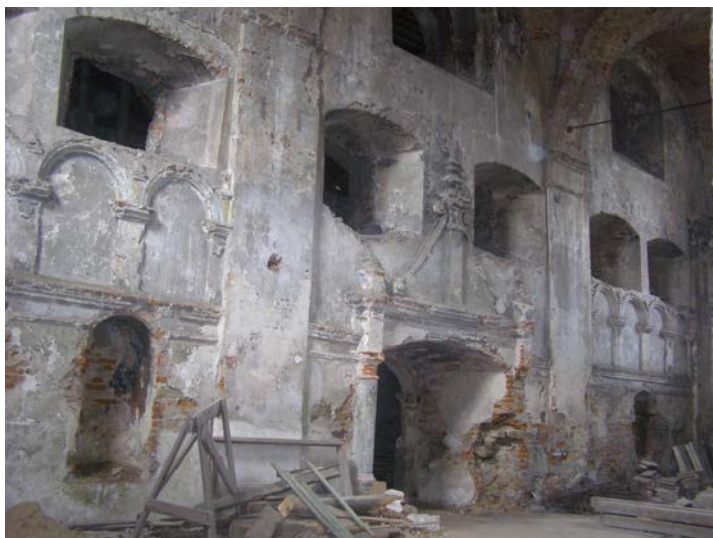
**Fig. 2.** Western wall of the main prayer hall in the synagogue of Zhovkva: photo taken in 2008.

The fire that happened in 1724 apparently triggered further building of the synagogue. Most likely, the work was concerned with the construction of western body with the synagogue premises, an entrance hall (pulisz), and a women's gallery above them. Somewhat later origin of the western synagogue premises was confirmed by outfit surveys, which had revealed traces of later building of the women's gallery at the western wall of the prayer hall (Fig. 9<sup>9</sup>). So, after 1724 the big cubic body of the prayer hall was covered with two porches – parterre southern and shallow western ones. Both were deepened, with stone stairs leading to them. Two tiers of stretched western premises were overlapped by brick barrel-shaped vaults with form takedowns that were lit through the round windows on the first floor and were semicircular on the second one. The women's prayer halls on the empora were connected with the main prayer hall by six windows hewed through, which had camber arches (Fig. 2). The existence of these windows was later showed up

by different inclinations of glyphs and different parts of segmental camber arches, as well as by that they undercut the completion of a blind-arcade belt (see Fig. 2 and Fig. 10). Three large windows were shortened by means of blocking them off in the bottom parts. There were two entrances to the main prayer hall in the western wall, which were decorated with white-stone Baroque portals [32]. The main entrance located on the axis was accented by a Renaissance cartouche. The portal has been preserved to this day. Setting of the portal against the aperture of door opening with segmental jumper strap, which was not integral (Fig. 11), may indicate of transfer of that portal from other buildings. In the measuring scheme by A. Grotte dated by the early 20th century (see Fig. 12), the thicknesses of walls of the southern and western annexes that appeared in a small time interval, was almost identical (~1.20 m). However, archaeological excavations from 2001<sup>10</sup> told us of different times of their erection. The exit to the roof was arranged in the western synagogue's body, in the mass of wall, which was continuation of the southern wall of the main prayer hall (Fig. 13).

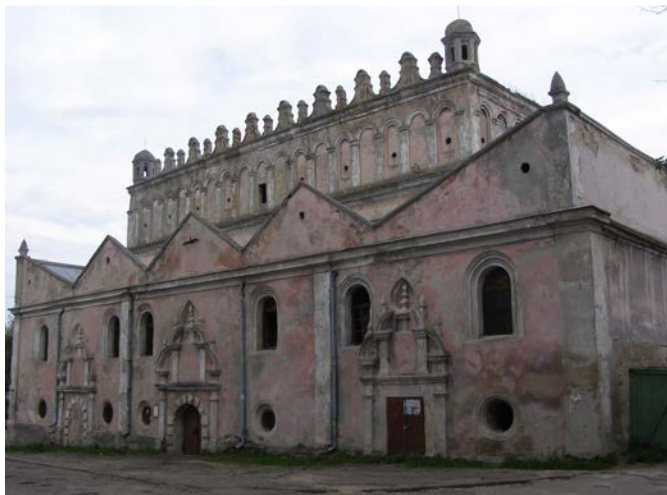
**Fig. 3.** Synagogue in Zhovkva. Western facade: photo taken in 2008.

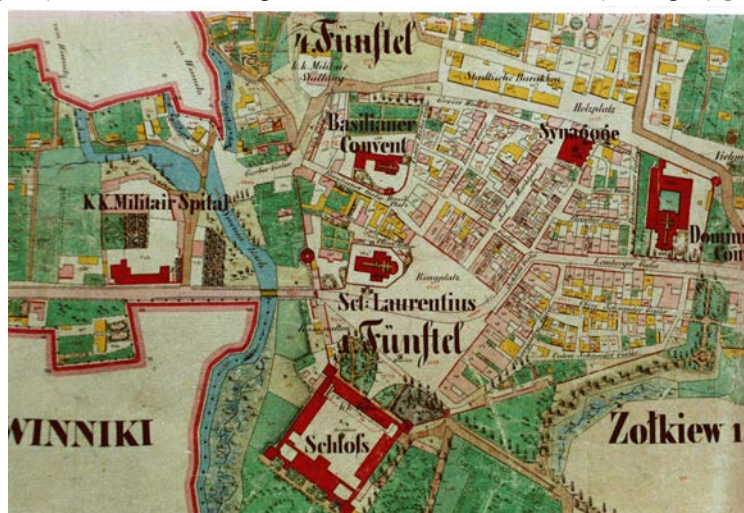
**Fig. 4.** The synagogue, the entrenchment (*Israeliten Friedhof*), and the Jewish Market (*Juden Marktplatz*) in the Zhovkva cadastre from 1854 (taken from the Central State Historical Archive of Ukraine in Lviv).

entirely in the hands of Jews. There lively bidding was being conducted. The street that led from the Rynok towards the synagogue turned into a market. It had got the name “Jewish Market” (Juden Marktplatz) on the cadastre map of Zhovkva dated from 1854 (see Fig. 4) [15].

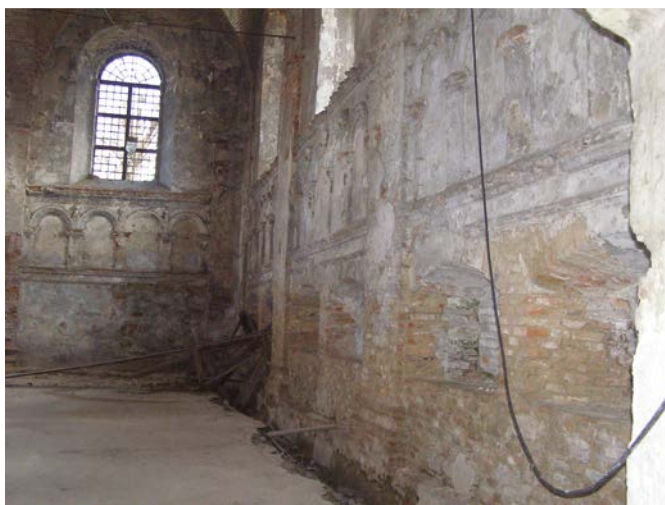
**Fig. 5.** Interior of Zhovkva synagogue. Views of the eastern and southern walls. Windows of the parterre women's gallery: photos taken in 2008.

built. It was joined with the men's hall by six small distinctive windows meant for hearing prayers rather than for visual purposes (see Fig. 5). These windows were laid simultaneously with the erection of the main body. They have been saved to this day, though are laid with stone from outside. In carrying out its function, the windows were placed high enough in a deep prayer hall for women (the level of floor paved with bricks was equal to 2.15–2.18 m, while the level of brick riprap was 0.24–0.30 m) [9]. The commu-

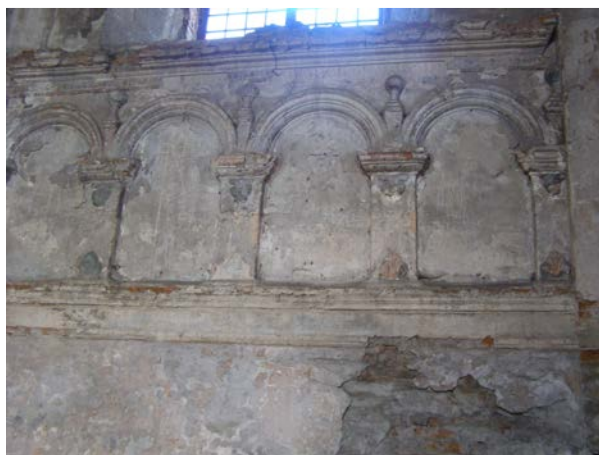
**Fig. 6.** Synagogue in Zhovkva. Fragment of blind-arcade belt under the windows of the prayer hall: photo taken in 2008.

Under the windows, the high walls of the prayer hall were decorated by a blind-arcade belt of the Tuscan Order, which divided the walls in the vertical direction (see Fig. 6). Such a decoration was characteristic of Renaissance and Baroque synagogues built in Halychyna and Volyn in the 17th and 18th centuries (the towns of Rzeszów, Lviv, Lisko, Dobromyl, Łańcut, Ostroh, Brody, etc.). The arch walls of the prayer hall of the ancient Zhovkva synagogue were based not on pilasters but on a large profiled cornice. A centricity underlined by the bema located just in the middle, was an original idea for solving a space and made a religious ritual more distinct [27]. According to observations by Zeichyk, this architectural organization was characteristic of Renaissance synagogues of Kraków, Kieleck and Lublin, and of the Ruthenian provinces [26]. The first example of synagogues of this type is considered to be the synagogue of Maharshalschul (Lublin, Poland) built in 1567 [26, 28, 29]. In 1594, a synagogue with a supporting bema emerged in Przemyśl (an architect Bononi; see Fig. 7) [30, 31]. Although the prayer hall of the latter was elongated, according to the pattern of ancient synagogues, and was overlapped by a system of tubby vaults with a form takedown (without arch walls), the synagogue had already a centred composition<sup>7</sup>.

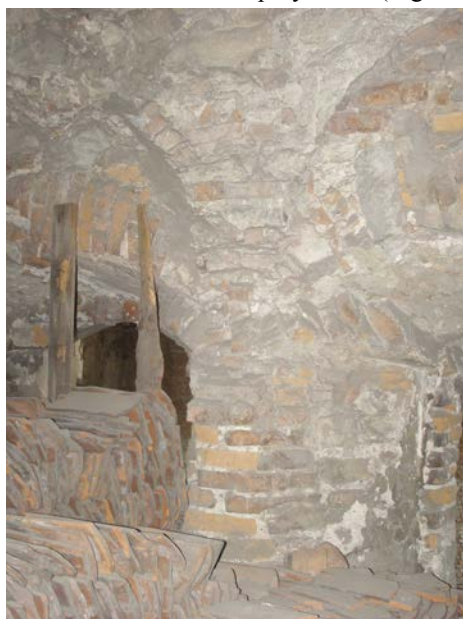
**Fig. 9.** Traces of rebuilding of wall of the western synagogue's body: photo taken in 2008.

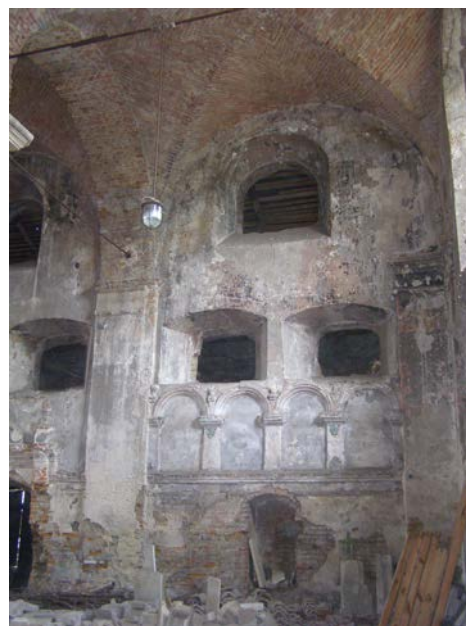
**Fig. 10.** View of the western wall. Blind-arcade belt cut by chopped holes of the women's gallery: photo taken in 2008.

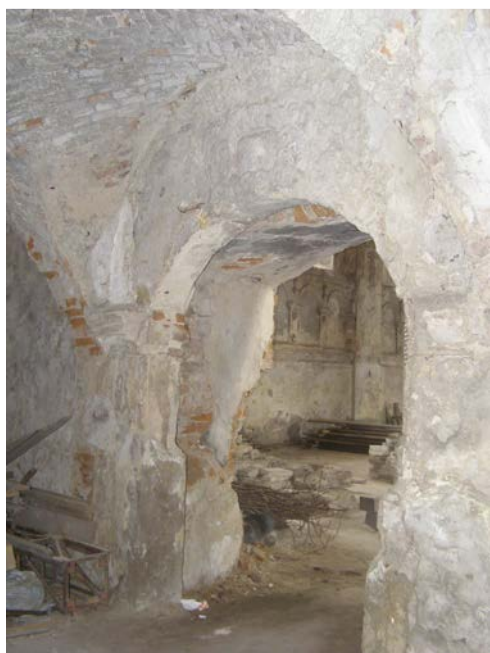
**Fig. 11.** Attached white-stone main-entrance portal with a cartouche: photo taken in 2008.

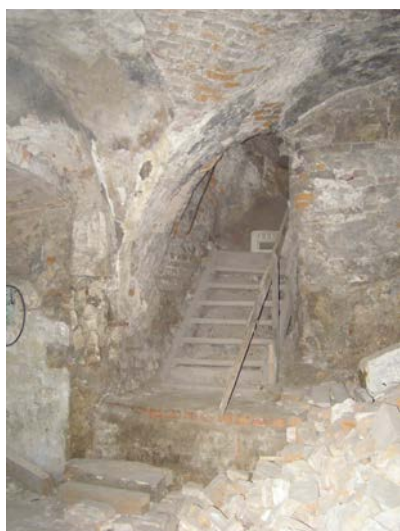
**Fig. 13.** Empora in the wall of western synagogue's body: photo taken in 2008.

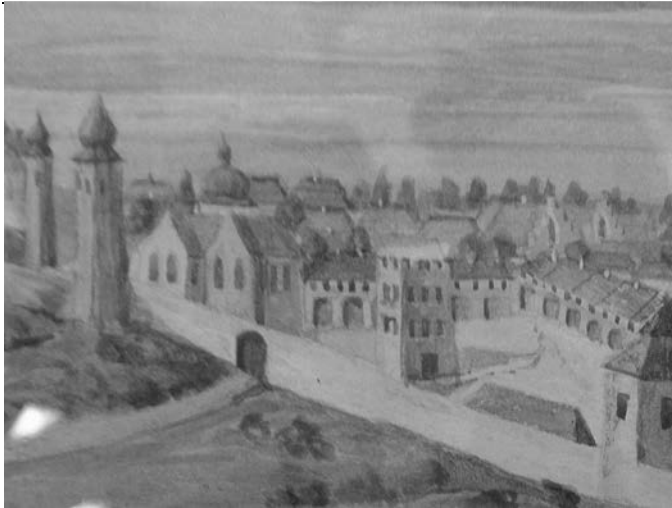
**Fig. 14.** Fragment of a watercolour by E.-K. von Kronbah that depicts Zhovkva, 1823. A building under high roof with a break is identified as the synagogue (Lviv Historical Museum).

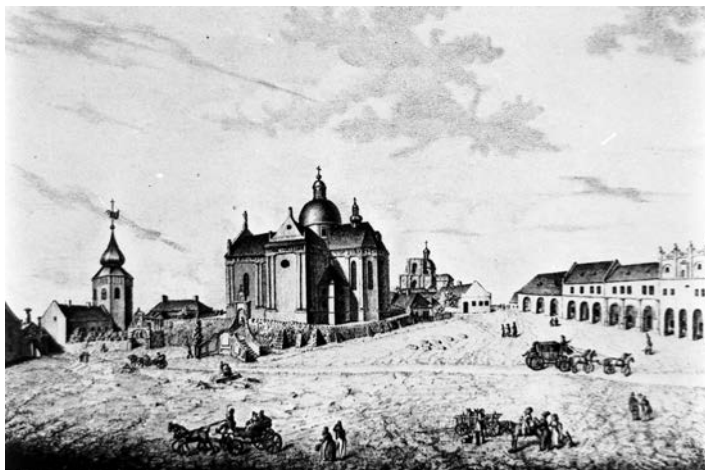
**Fig. 15.** Rynok Square in Zhovkva as it appears on the engraving by Zhyhovych from the middle of the 19th century. The stone building adjoining the Square, with an attic, represents a so-called "royal building"; the architect and builder P. Beber.

Now it is unknown whether the Zhovkva synagogue contained an attic, which hid a folded roof, or it was covered by a four-backfall roof. If it was really built by P. Beber, then we could assume that it did have an attic and the latter was similar to the attic of the Zhovkva Town Hall or the near-Rynok royal building No 13 built by him, too. The Town Hall with an attic was recorded in two watercolours of the early 19th century, by an unknown artist and by a topographer E.-K. von Kronbah (Fig. 14) [33], while the near-Rynok stone building was depicted on a lithography by Zhykhovych (the middle of the 19th century – see Fig. 15). According to Jakób Schall, the old

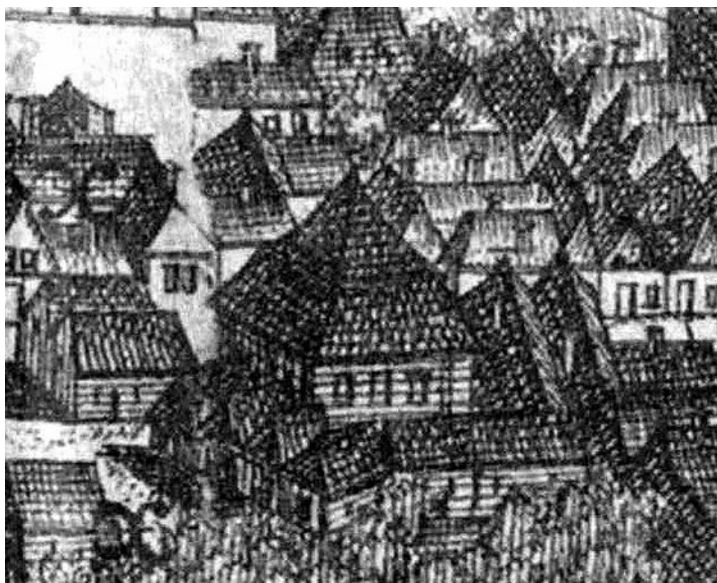
**Fig. 16.** Great Suburb synagogue in Lviv on the engraving by Perner (1772). According to: D. Zubrytskyi, *Chronicle of the city of Lviv*. Lviv, 2006

Zhovkva synagogue had an attic and, moreover, it contained forms<sup>11</sup> and loopholes, and later was remade according to a pattern typical of the Renaissance Kraków attic (i.e., without a crown) [2]. In the panorama of Zhovkva by Kronbah (1826), the building located approximately in the place where the synagogue must have been, is shown under high roof with a break. If the synagogue really had an attic, then the artist would have surely fixed it. At least beginning from the middle of the 18th century, high Baroque roofs covered a majority of ancient synagogues. In particular, this was peculiar of the Lviv Great Suburb synagogue till 1870 (see Fig. 16)<sup>12</sup>.

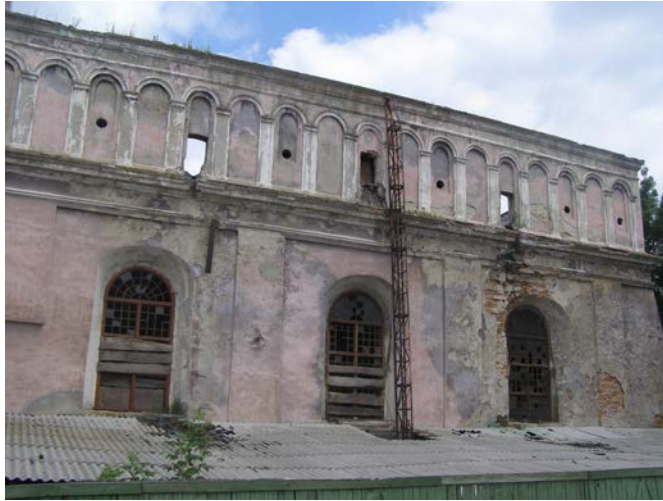
**Fig. 18.** Synagogue in Zhovkva. Southern facade. Openings in the windows reveal signs of lowering: photo taken in 2008.

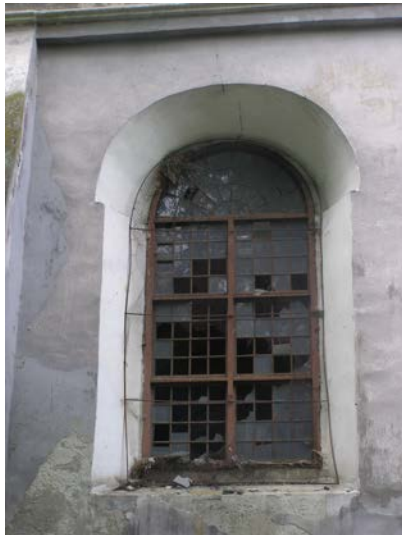
**Fig. 19.** Traces of lowering of a window on the northern facade: photo taken in 2008.

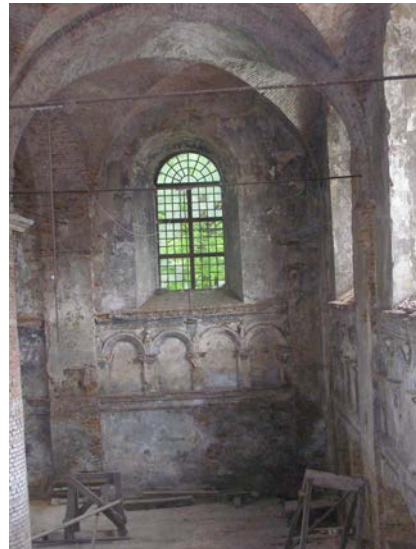
**Fig. 20.** Fragment of interior of the synagogue that includes an extreme window, of which axis does not coincide with the axis of the vault: photo taken in 2008.

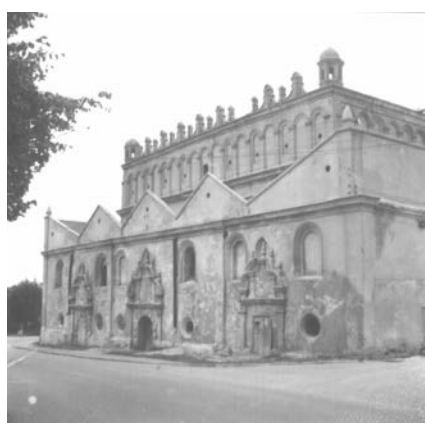
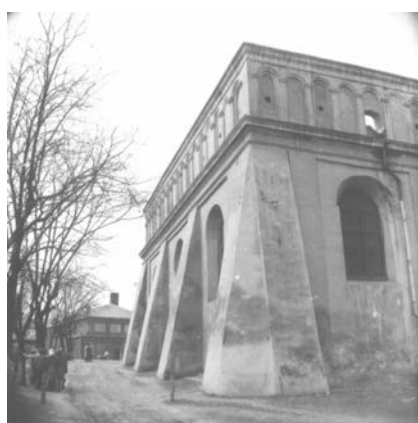
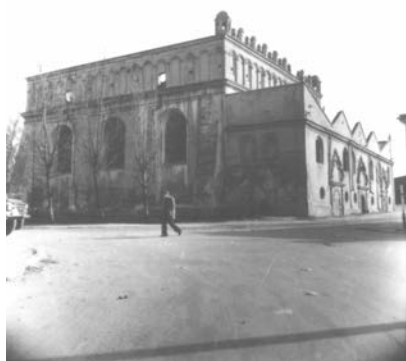
**Fig. 25.** Synagogue in Zhovkva after repairing and restoration works of 1955–1956. Views of the main facade (a); from northwest (b) and northeast (c): photos taken by V. Olkhomiak, 1957, Lviv.

The strong buttresses that strengthened the eastern and northern walls, gave the synagogue a monumental character (see Fig. 25a). Their later origin could be claimed basing on the facts that the corresponding brickwork meant no ligation with the walls, whereas the brick was made in the 19th century. On the draft cadastre from 1842 [43], the synagogue was depicted with no buttresses, though the latter were already recorded in the cadastres referred to 1854 [44] and 1872 [45]. The

The open brick walls of the synagogue were finally plastered (see Fig. 25 displaying the photos by V. Olkhomiak dated from 1957). Unfortunately, these works had affected neither the portal of the main entrance into the prayer hall, nor the Torah niche, the destruction of which is continuing in our days (see Fig. 35 and Fig. 36).

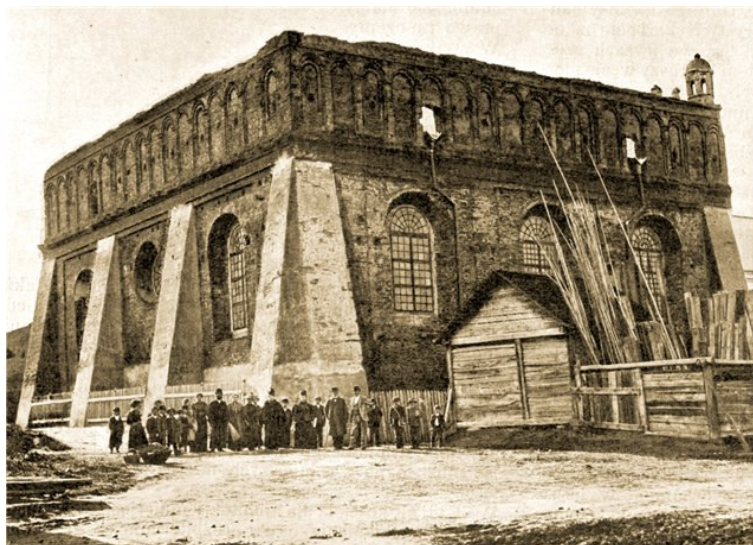
**Fig. 26.** Synagogue in Zhovkva before its restoration carried out in 1908. View from the northeast.  
The source: [www.bagnowka.com](http://www.bagnowka.com)

The question of restoration of the synagogue was put because of its bad condition at the beginning of the 20th century (see Fig. 26). This fact was reported in the documents stored at the Lviv Historical Archives, in particular in the correspondence between the community and the Conservation Office. The head of this administration L. Finkel supported the idea of restoration. On November 10, 1904 the Jewish community addressed a letter to Dr. Yuliush Shumlanskyi, a

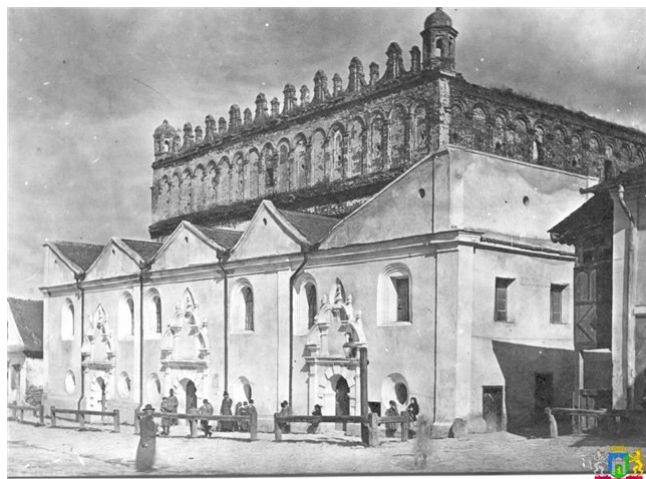
**Fig. 27.** Synagogue in Zhovkva before the restoration carried out in 1908: photo taken in the early 20th century. Lviv Historical Museum.

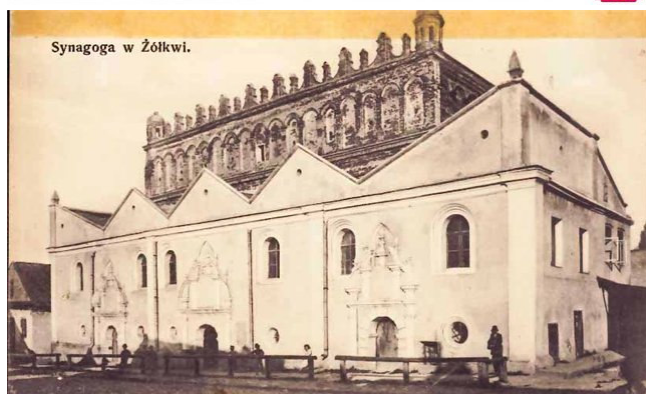
**Fig. 28.** Synagogue in Zhovkva after the restoration works carried out in 1908. The source: [www.bagnowka.com](http://www.bagnowka.com)

bright festoons. As characterized by M. Balaban, this looked “not unlike a bad summer theatre or a wine tavern of those days” [20]. The documents of the Conservation Office stated that the walls of the synagogue were re-painted by the Lviv theatre artist Zygmund Balk so that the remnants of polychromy originated from the first half of the 19th century, were destroyed. The attempts by the Grono to exert pressure on the community, in order to get the new “unaesthetic” paintings removed, had not crowned with success [49]. Obviously, some restoration of the facades was then also performed, as could be seen from the photos taken in different years (see Fig. 27 and Fig. 28). In particular, the attic was restored, including its coronal cornice (Fig. 29); the western synagogue’s body was emphasized by two obelisks on its sides, while the shape of the extreme (from the south) window on the front facade was changed from rectangular to semicircular.

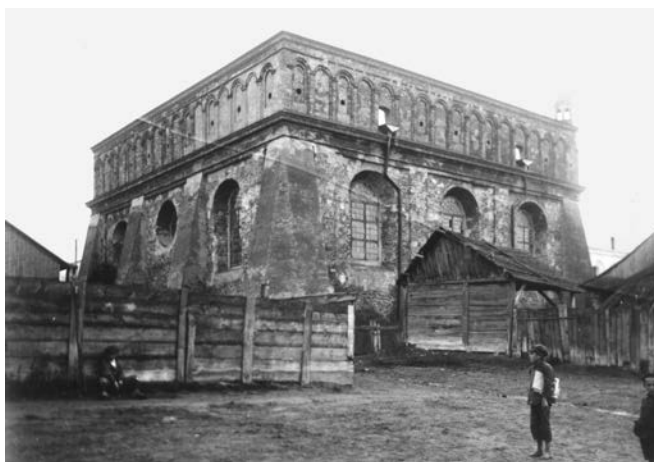
**Fig. 29.** Synagogue in Zhovkva from the northeast: photo taken in 1920s. National Museum in Lviv.

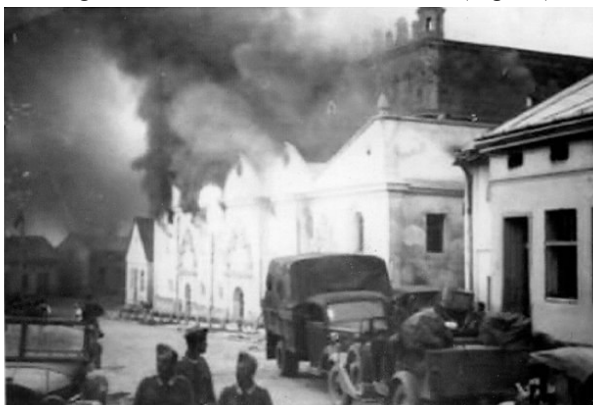
**Fig. 31.** Synagogue in ruin. View from the southwest: photo taken in the late 1940s. According to: Collection by V. Nakopalo, Lviv.

Already in the early days of German occupation, in 1941, the Nazis tried to destroy the synagogue. After attempts to undermine it (see Fig. 30) the southern women's gallery was completely destroyed, while the western body lost its roof and the ceiling empora (only traces of the latter had remained). Three fields of vaults and columns were destroyed in the main prayer hall, together with the roof above that hall (Fig. 31).

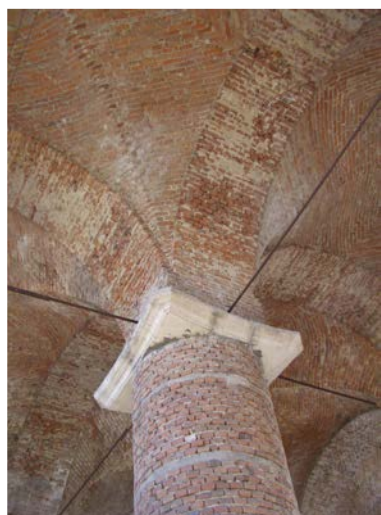
**Fig. 33.** A column and an arch of the main prayer hall reconstructed in 1955–1956: photo taken in 2008.

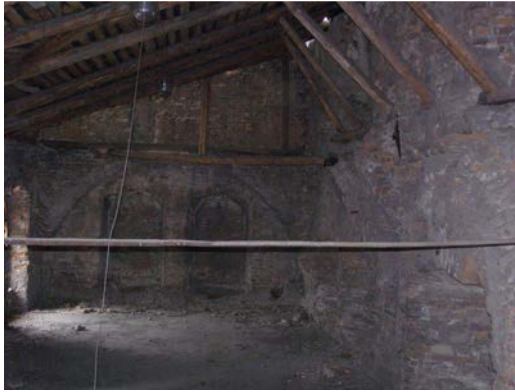
**Fig. 34.** Temporary roof over the western synagogue's body: photo taken in 2008.

the two entrances in the front facade sealed, along with all the six windows of the shattered southern woman's prayer. Instead of the folded roof over the western synagogue structures, a protective lean-to roof was built, which covered three windows of the main prayer hall (Fig. 34).

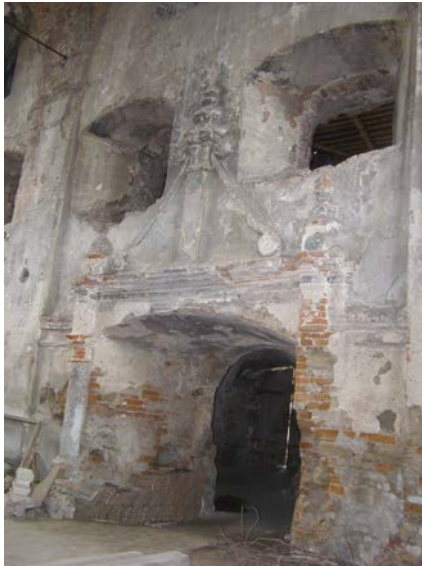
**Fig. 35.** Main entrance from the direction of the prayer hall: photo taken in 2008.

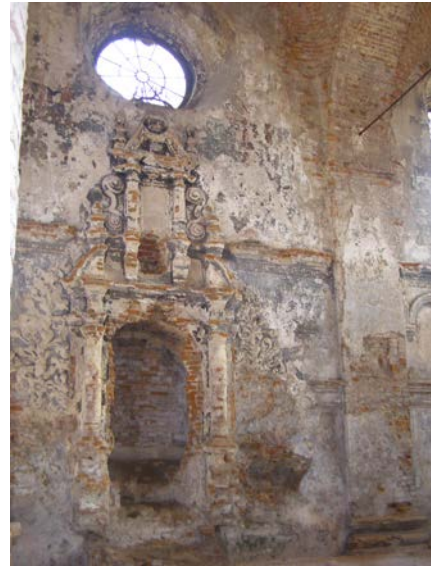
**Fig. 36.** Synagogue in Zhovkva. A preserved niche of Aron Kodesh at the axis of the eastern wall of the prayer hall: photo taken in 2008.

Kodesh in the eastern one. Notice that the deep Torah niche laid down during the construction of the synagogue is preserved till now.

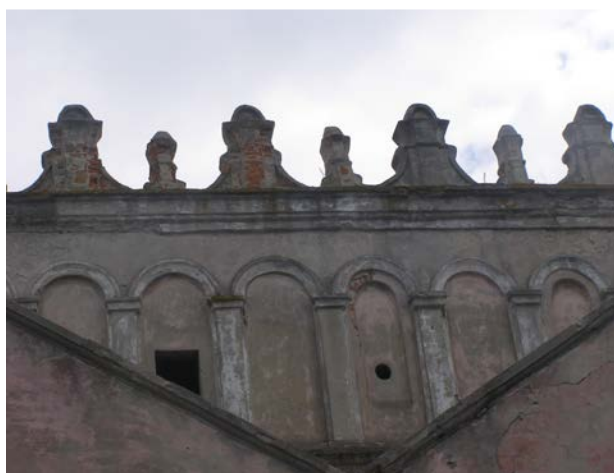
**Fig. 38.** Fragment of attic above the main body: photo taken in 2008.
