Assembly of the stand roofing steel structure for the football stadium in Gdansk

Abstract. The technology of stand roofing assembling for the stadium built in Gdańsk for the European Football Championship – EURO 2012 was discussed. The stadium has a characteristic silhouette, its shape and colors of the façade resembling a cut block of amber. The steel structure of the roofing over the stand of quasi elliptical form, with the maximum diameter of 220,0 m and minimum diameter of 187,0 m, is 38,0 m height, the roof girders having a reach of 48,0 m. The roofing structure weight is 7150,0 ton. It was assembled in 226 days.

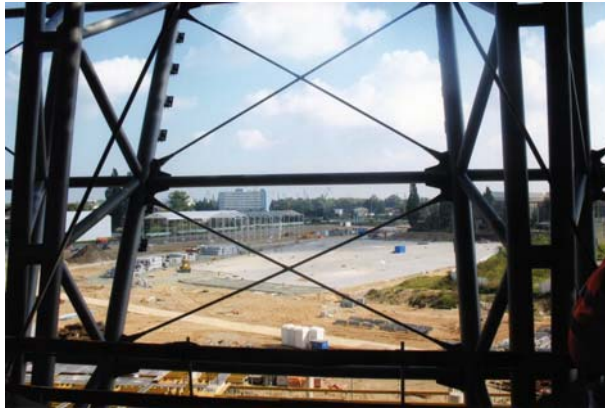
Fig. 3. Bracing between neighboring girders: ring-shaped (horizontal) made of pipes, cross braces made of circular bars

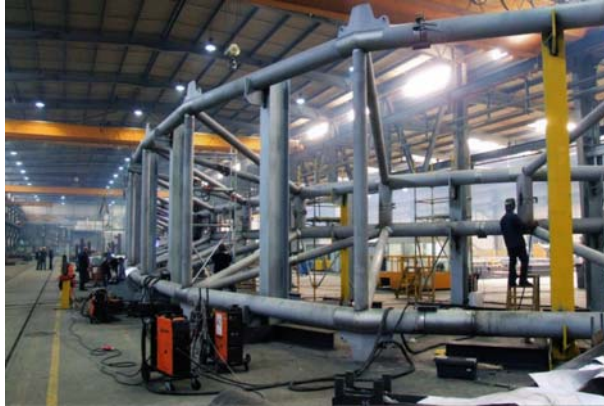
Fig. 6. Trial assembly of a three-dimensional roof girder at the plant in Gliwice (photograph courtesy of the Investor)

Assembly. Cutting of pipes for framework bars to be joined together at various angles and chamfering of edges for welding in various positions were performed at mechanical works in Kosice and partly also at works in Hungary cooperating with them. The pipes prepared in such a way were transported to the Martifer Metallic Constructions plant in Gliwice, where they were joined together into units having dimensions suitable for road transport to Gdańsk. Prior to shipping a trial assembly on special frames was performed at the Gliwice plant (Fig. 6), together with covering the units with a layer of anti-corrosion primer and the first coat of paint. After having been checked the girders were dismantled to be transported in parts to Gdańsk on multi axle trailers (Fig. 7).

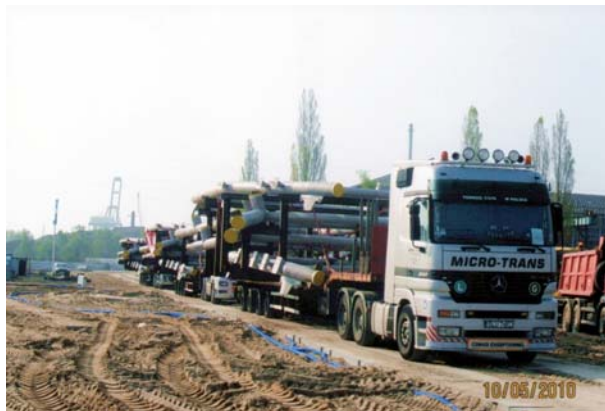
Fig. 7. Transportation of roof girder parts from the plant to the construction site (photograph courtesy of the Investor)

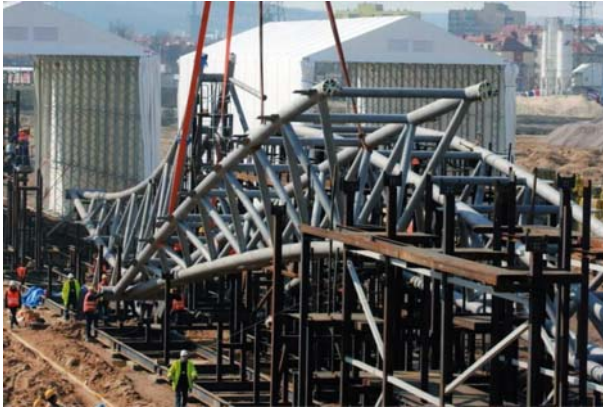
Fig. 8. Assembling of roof girders on site on two parallel assembly transoms (movable tents for protection of welding works on rainy or windy days can be seen in the background)

After having arrived at the construction site parts of the roof girders were stored along assembly transoms, which were equipped with special tooling consisting of posts with brackets, platforms and grips to facilitate assembling and welding of the structures. In good weather welding was performed outside, while on rainy days or in strong winds it was executed inside the special protective tents. The tents, movable along tracks laid on both sides of the transoms, could be shifted over those zones where welding was being done (Fig. 8). A protection tent had the following dimensions: the spread of 13,0 m, height of 12,62 m, length of up to 35,09 m, depending on the number of modules 2,92 m long. The tent had a steel framework mounted on carriages, which allowed it to be moved along the track. The side walls and the roof were made of non-flammable PVC

coated polyester fabric stretched across the steel framework. The end walls, made of the same material, were of folding type. These tents were also used for protection of assembled units during repairs of the anti-corrosion paint coat applied at the plant and damaged in the vicinity of welds made on site or mechanically damaged during transportation.

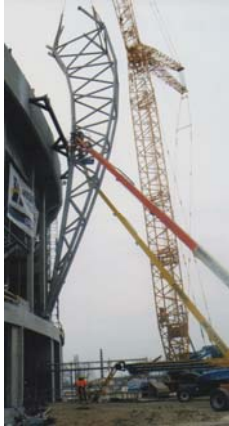
Fig. 9. The first assembled “façade” part of a roof girder (02.04.2010). The instant of temporary fastening of the girder to the segmented steel ring on the reinforced concrete stand crown beam

The lower sections of roof girders (the so called “façade” sections), bonded and checked thoroughly for correctness of joining, were transported directly to the reinforced concrete structure of the stand and mounted on the articulated bearings (Fig. 9). The respective roof girders had to be fastened to the reinforced concrete crown beam on the stand top until the entire stand roofing structure was assembled. That was done with the aid of segmented steel ring made of successively mounted double-tee bars. Bars of the roof girder lower belt were fastened to the ring using steel stirrup bolts (Fig. 10).

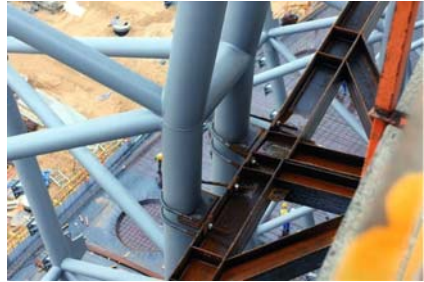
Fig. 10. Bars of a roof girder lower belt connected temporarily with stirrup bolts to the steel ring on the stadium stand reinforced concrete crown beam

reinforced concrete crown beam on the stand top. The roof carrying structure had to become independent of the reinforced concrete structure. Cutting of the stirrup bolts joining the steel girders with the reinforced concrete structure (see Fig. 10) stirred up a lot of emotions, as that could not be done for all of 82 girders simultaneously. One was afraid that successive releasing of the girders from those temporary joints could result in local unstressing of the steel structure and hence its deformation. However, no such effect took place.

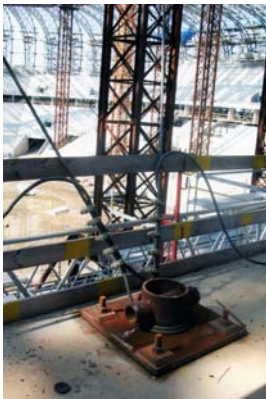
Fig. 11. Anchorage of mounting tower stays to the reinforced concrete structure of the stadium stand (stays of two neighboring towers were fastened to one anchor)

In order to set about assembling “roof” sections of the carrying girders it was necessary to erect inside the stadium 22 mounting towers for supporting lattice beams on which the end sections of the stand roofing carrying girders would be put. For the layout of mounting towers see Figure 1. The towers had the form of axially compressed steel framework pillars with square cross sections, each of them having the base tied to the reinforced concrete structure of the stand foundation and the head stabilized with four stays. Two of the stays were anchored at the bottom to the reinforced concrete stand structure (Fig. 11), while the remaining two were fastened to the ground anchors made under the stadium pitch (Fig. 12).

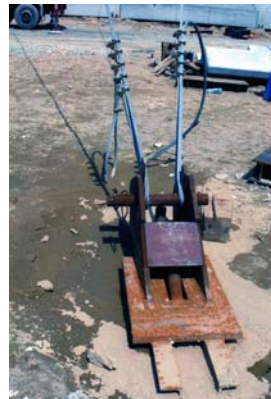
Fig. 12. Anchorage of mounting tower stays within the stadium pitch – a ground anchor (note as for Fig. 11)

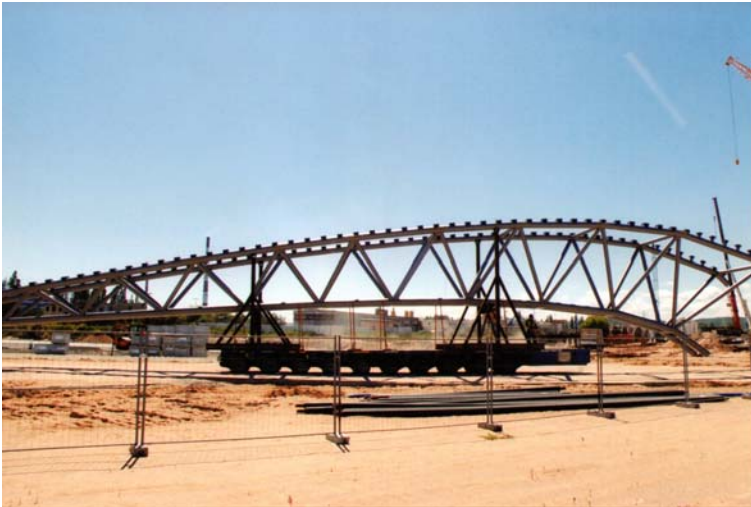
Fig. 13. A “roof” section of a roofing carrying girder (about 48 m long) transported on a self-propelled multi axle platform from the paint shop tent to the mounting crane

The “roof” sections of girders, bonded and checked thoroughly for correctness of joining, were transported to the assembling crane on special self-propelled multi axle platforms (Fig. 13). They were fitted there with scaffolds necessary for safe work at heights, and accessories to facilitate joining to the previously mounted “façade” sections of the girders.

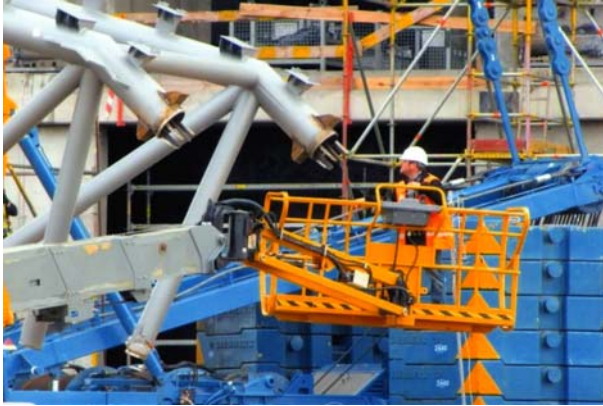
Fig. 16. Ends of the upper belt bars of a girder “roof” section fitted with fixtures to facilitate assembling

Assembly joints of girder belt pipes had been designed as butt joints welded on one side. To facilitate joining of the pipes guides made of four crossing metal sheets were welded inside the pipes of the section to be assembled. Protruding portions of the sheets narrowed toward the ends, thus forming truncated cones which centered the pipes being joined (Fig. 16).

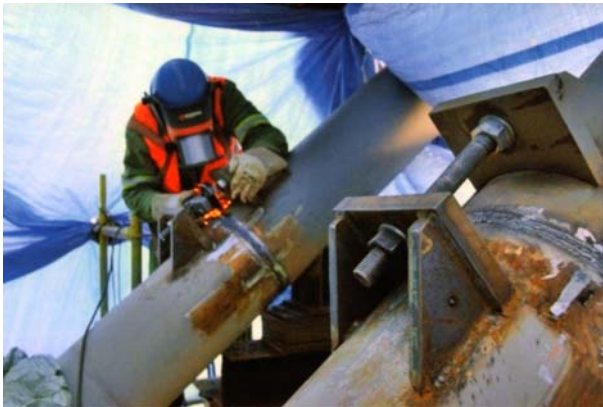
Fig. 17. Accessories for adjustment of the weld groove width of the girder upper belt pipe joint

To make possible adjustment of the weld groove between the pipes to be joined thrust pieces were welded near the edges of both pipes (Fig. 17). These pieces were linked together with bolts provided with nuts below and above the thrust plate. By turning the nuts one could adjust the pipe edge spacing so as to ensure a thorough penetration of the weld made on site.

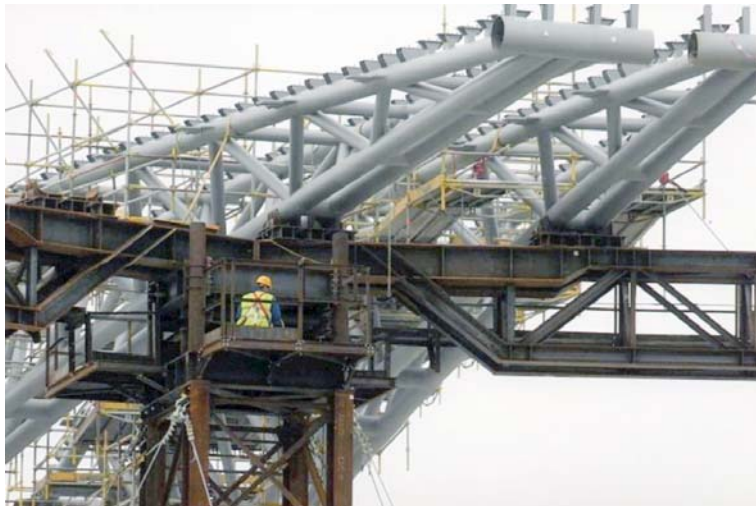
Fig. 19. Tips of two adjacent girders resting on the supporting beam. Components of the main linking ring measuring $\phi 500 \times 20$ mm can be seen on the girder tips

Figure 19 shows tips of the first two assembled roof girders; the tips end with segments of the linking ring. On completion of all girders assembly and welding of the missing sections of this ring it became the main linking ring playing the essential function in the roofing behavior.

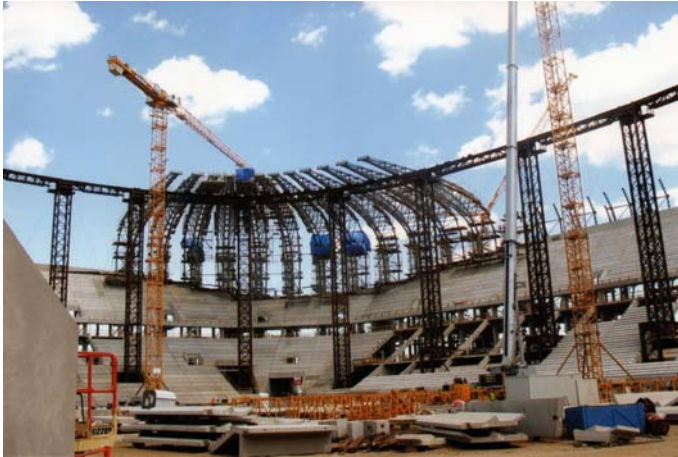
Fig. 20. Assembled 12 “roof” segments of the stand roofing carrying structure

Figure 20 shows a further stage of the construction work – assembling of twelve carrying girders.

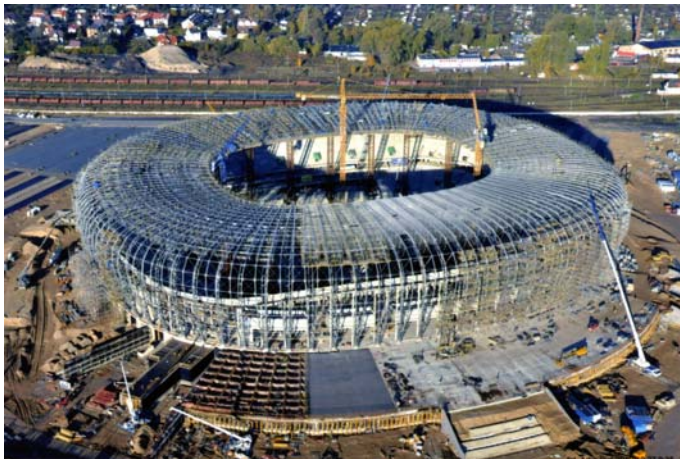
Fig. 21. Completely assembled roof carrying steel structure of the stadium (31.08.2010
– photograph courtesy of the Investor)

The completely assembled roof carrying structure is shown in Fig. 21; Fig. 22 shows Prof. A.V. Shimanovskij and Eng. I.B. Shumovskaya visiting the construction site.
