Pavlyuk D.O., ScD, Professor
ntu-pavluk@yandex.ua
Tereshchuk V.P., post-graduate
tervit@mail.ua
Chapovskyi V.S., post-graduate
foxsters@inbox.ru
National Transport University, Kyiv

ROADWAY ROUGHNESS RESEARCH AND CAUSES DETERIORATION ANALYSIS

The purpose of research – longitudinal profile of trafficway research road section H-18 analysis and road topping deterioration causes revealing.

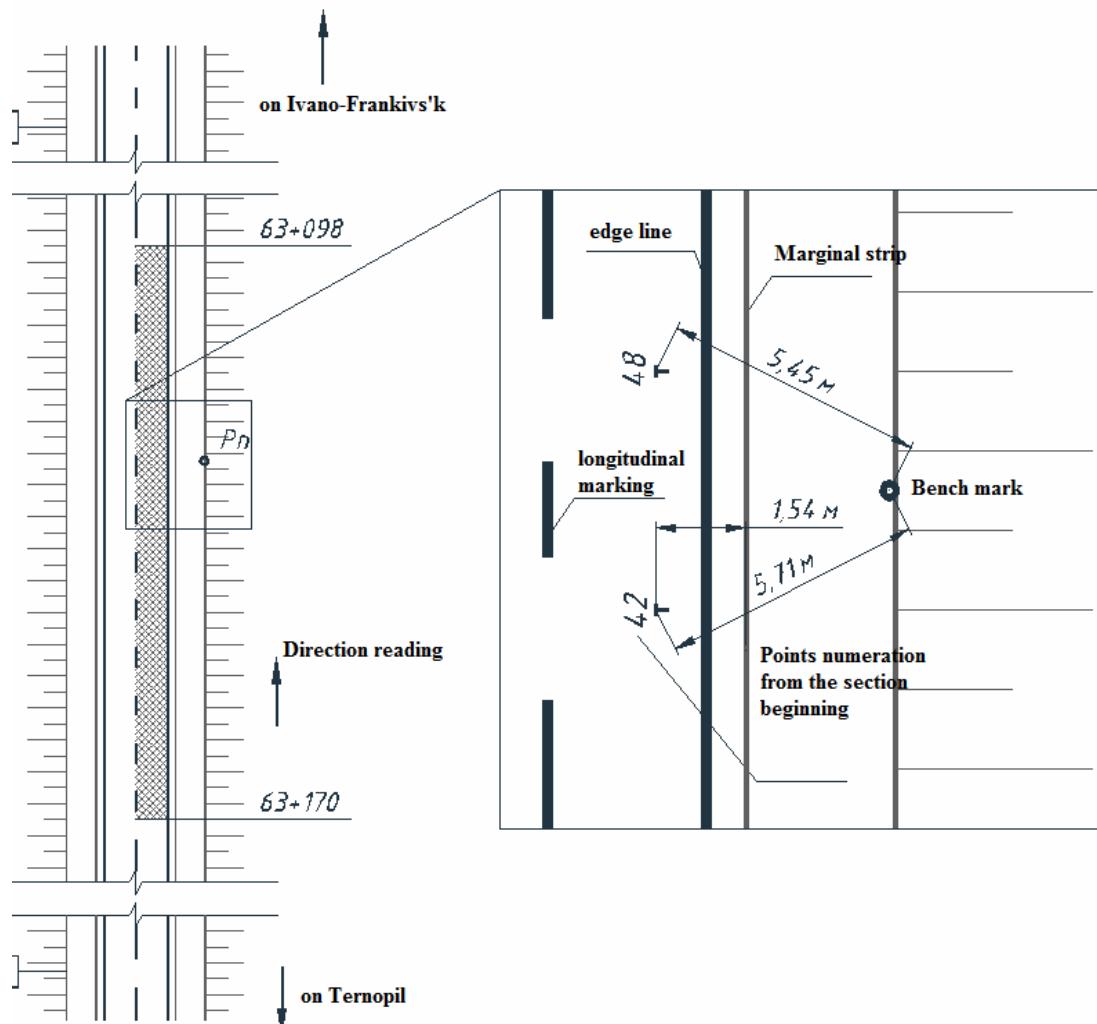
**Figure 2 – Scheme of road section H-18
Ivano-Frankivsk – Buchach – Ternopil (km 63+098 – km 63+170)**

- bench mark fixation (Fig. 2) and its recovery after repeated researches;
- flagging for measurement at a distance of 0,5 – 1,0 m from the marginal strip by using measuring tape and chalk and planimetric position georeferencing to the bench mark;
- route leveling with survey increment of 0,5 m and high-altitude position georeferencing to the bench mark.

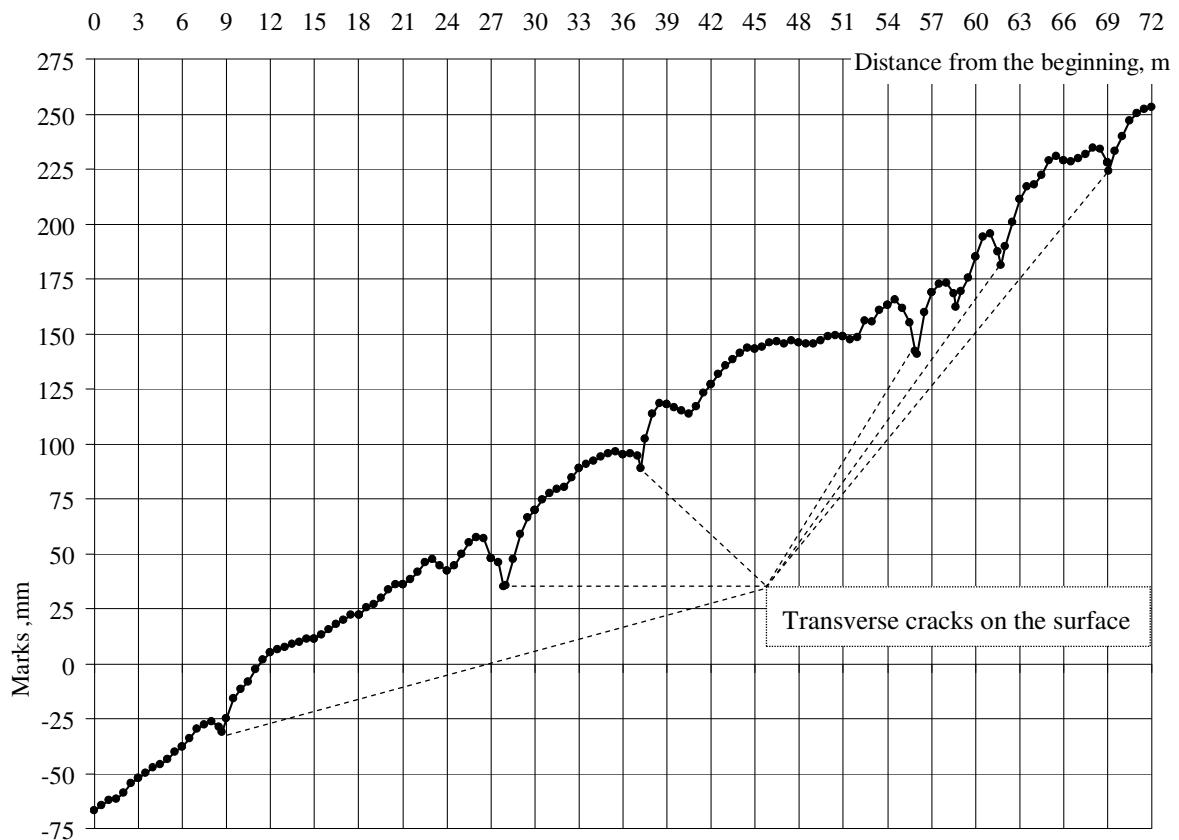
Figure 3 – Longitudinal profile of the right trafficway track

Longitudinal profile leveling results is shown on Fig. 3, where you can see the characteristic hollows, what, according to the authors, causes to blows. On profile reduction points it is continuous transverse cracks (Fig. 4).

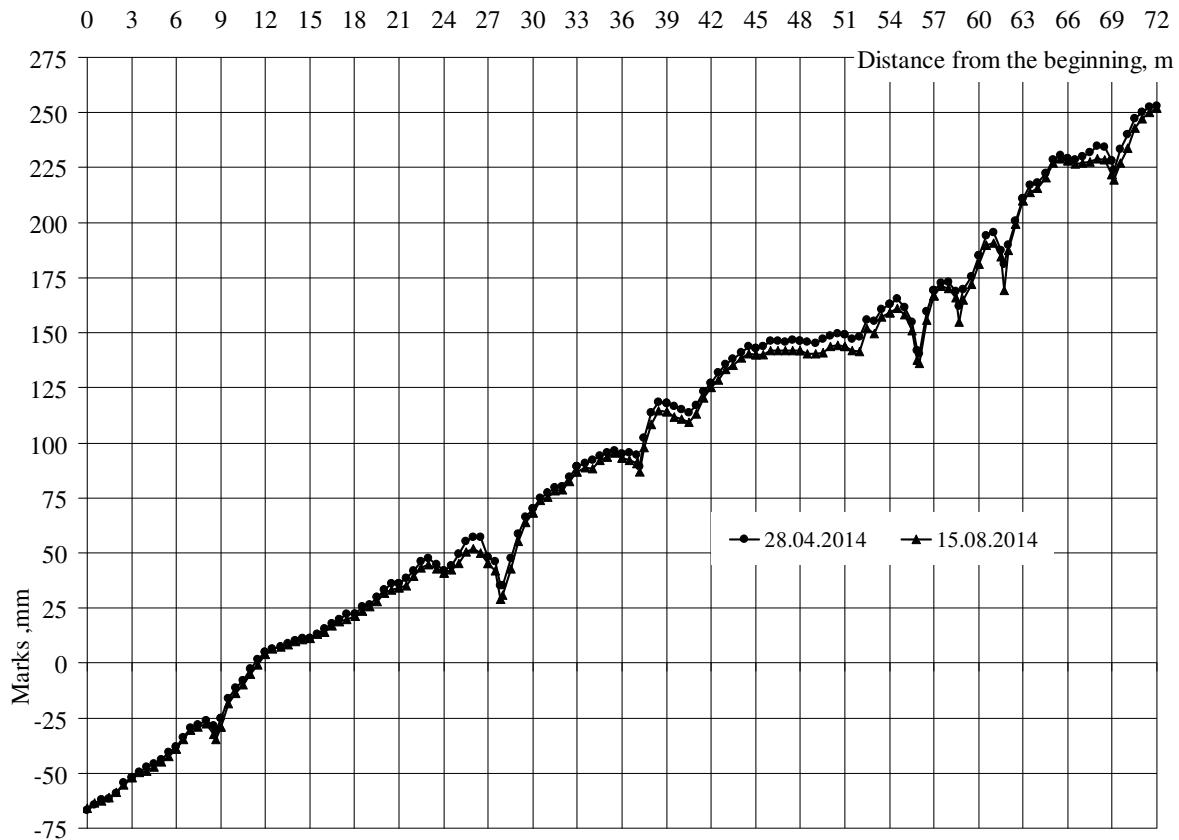
Figure 5 – Location of core taking points in the longitudinal profile section

In order to explain the road topping irregularities causes and cracking it is taken the samples in certain places – on crack (km 63+114,10) and in a place with no visible defects (km 63+105,00) (Fig. 5).

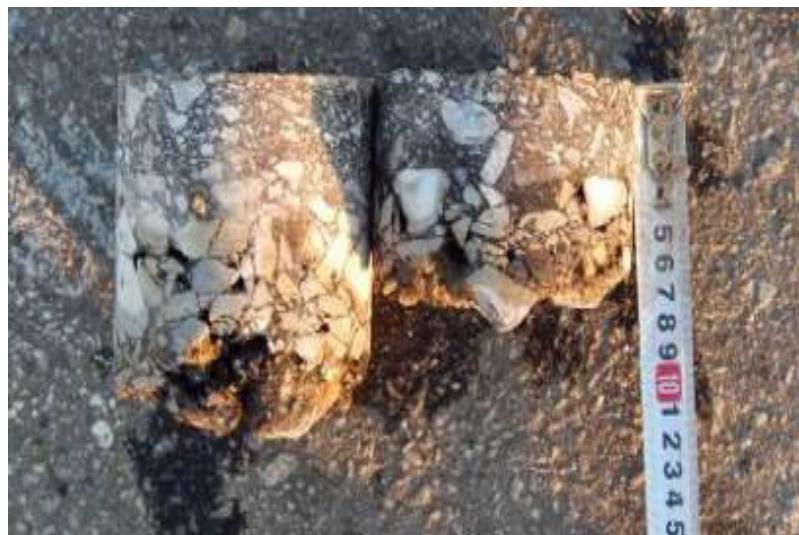
Figure 6 – Road-mat cores

Comparison of road-mat cores taken without defects and at place of transverse crack passing through is shown on Fig. 6.

As shown on Fig. 6, left road-mat core that taken on the road section without defects (km 63+105,00) has the upper layer of fine graded bituminous concrete with thickness of 4,5 cm, lower layer – coarse bituminous concrete with thickness of 7 cm. Right core, taken on the road section in a place of transverse crack passing through (km 63+114,10) has a thickness layers respectively 3 and 4 cm.

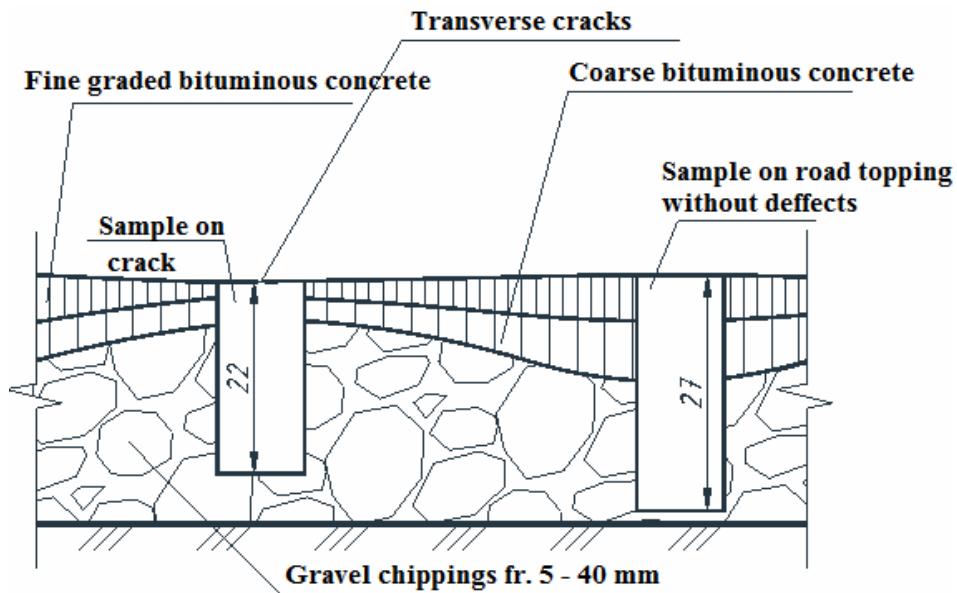
Figure 7 – Schematic representation of longitudinal profile road-mat cores

Situation's arisen, can be represented schematically on Fig. 7.

Longitudinal profile hollows and transverse cracks caused by layers uneven thickness along the road length. In the places of reduced layers thickness it is a weakening of the road-mat profile cross-section, so when the environment temperature is reducing in these places there was a gap that led to the cracks formation.
