CHANGES IN THE COURSE OF THE VISTULA RIVERBED VS. THE RISK OF FLOOD ON THE TERRITORY OF SANDOMIERZ

Keywords: flood, Vistula, river regulation

ISSN 0868-6939 Фізична географія та геоморфологія. – 2013. – Вип. 4(72)

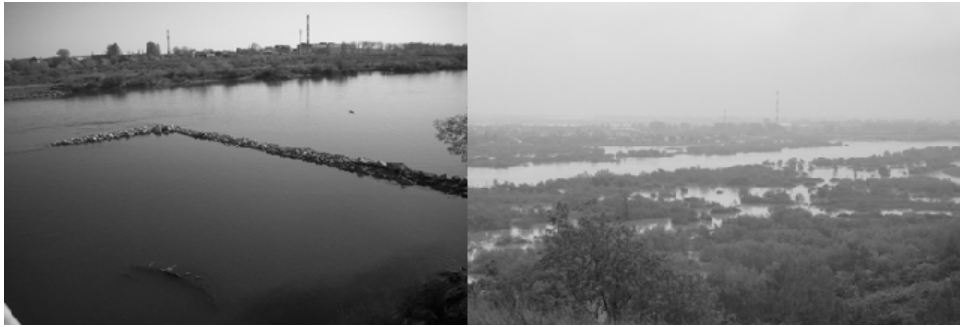
Phot. 1 – A Transversal Dam on the Vistula in Sandomierz and the Inter-Embankment Zone within the Town’s Territory Covered with Wicker, Bushes and Trees

Plans for further regulation were interrupted by the outbreak of the second world war. By then, it was managed to build embankments along the entire length of the Town. The river, that was regulated in such a way, had to reach a depth of 1,5 m. However, due to low water levels, shallows started to emerge on both its sides. Because of large amounts of carried sediments, the depth varies from 1,5 to 4 m. In the years of 1903–1909, it was managed to build two river ports. One of them covered the area of 25 000 m², and the second one was located at the foot of the castle. Regulations of the Vistula were continued in the interwar period, and the result of those works were transversal dams, known in the region as “traverses” or “caps” (Phot. 1) [14].

These dams, also called “spurs”, start with the bank and cut perpendicularly through the river current. They are mostly used in order to move the current away from the banks, and form calm water areas in the brink zone of spurs. These spurs, on the territory of the Town, are made of gravel and stone material [3].

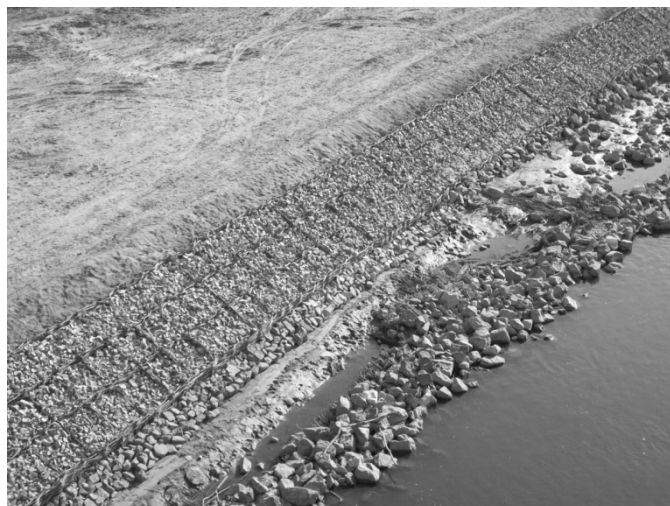
Phot. 2 – The Example of Stone and Fascine Dam on the Vistula Bank Source: From the author's private archives.

The study by W. Wiacek [14] indicates that the wicker, causing problems in the inter-embankment zone today, was planted there intentionally. There were created vast wicker plantations that provided valuable material for building fascine dams (Phot. 2) [6]. It also played the role in protecting and preserving the banks.

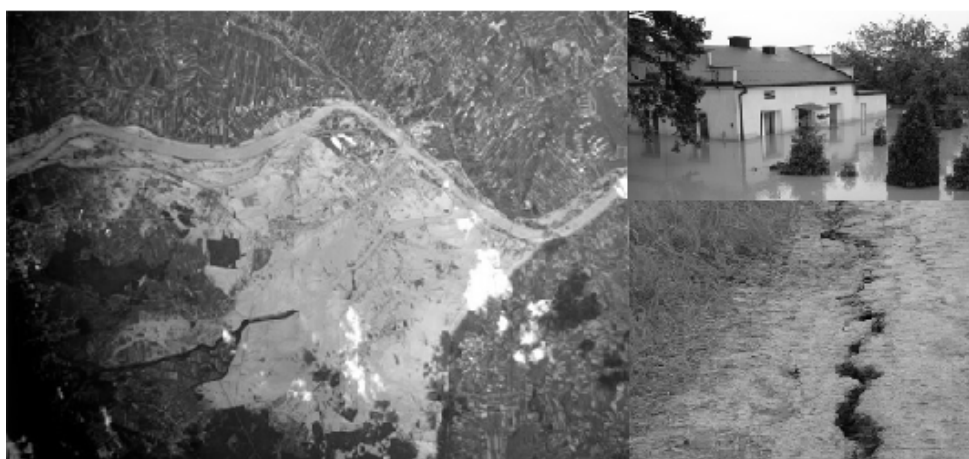
Fig. 2– The Territory of Sandomierz and its Surrounding Areas Flooded as a Result of Breaking the Embankment in Kocmierzow

The flood that occurred in 2010 led to inundation of the right-hand part of the Town. Due to exceeding the alarm level on 17th May, the Vistula threatened the right-bank part of Sandomierz. The weakest point was in Kocmierzow where embankments, were being additionally strengthened, from 18th to 19th May, with the construction of a temporary clamp. The Vistula broke the temporary clamp on the 50-metre-long embankment. The 2,5-metre-high wave culmination reached the Town on 19th May at 10 p.m. The huge mass of water (240 m/s) overflowing the breach led to evacuation of that part of the Town and the Tarnobrzeg suburbs inhabited by 4500 people. At that time, the Vistula exceeded the alarm level by 7 m. The entire right-bank part of the Town was flooded (Fig. 2).
