## APPLICATIONS OF GROUND PENETRATING RADAR IN BRIDGE HEALTH MONITORING AND ASSESSMENT

This paper presents a full case-study of applying GPR in assessing the actual condition of the "Pentagon Road Bridge" in Chatham, Kent, England. This study is part of a larger study which considers other NDT methods in conjunction with each other in order to produce a clearer picture of the health of bridges.

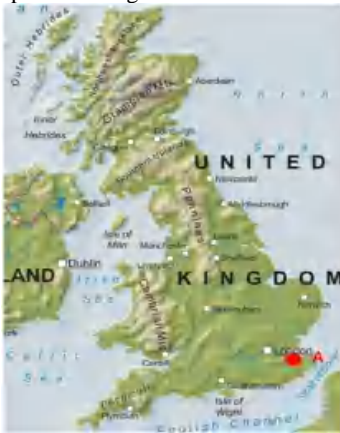
Figure 1 – (A) Pentagon Road Bridge in Chatham, Medway, England.

Pentagon Road Bridge (Fig. 1) was constructed in 1975 and carries an access road from Rope Walk to the Pentagon Shopping Centre in Chatham, Kent. The bridge is believed to be a four span simply supported concrete deck of beam and slab construction. At the west end, high end, the bridge links the access road to the rooftop car park of the shopping centre. The end support is a leaf pier that is shared with the access road. There is a lower access road for buses that is a brick faced concrete abutment at the east, low end of the bridge. At the east end there was a pedestrian walkway beneath the deck but it has been removed. The bridge foundations are spread footings.
