FAILURES OF SEWER PIPES MADE OF PVC / УШКОДЖЕННЯ КАНАЛІЗАЦІЙНИХ КАНАЛІВ ВИКОНАНИХ З ПВХ ТРУБ

© *Kuliczowska E., Gierczak M., 2013*

This paper presents the field measurements results of sewer pipes made of PVC, which were newly laid in the ground. The research was carried out applying CCTV (Closed Circuit Television) inspections, which was performed during the construction works acceptance of the sewer pipes some weeks or months after their laying in the ground. More than 11 km of sewers from 11 cities in Poland were analyzed. The analysis was carried out based on the research conducted among other things by Kielce University of Technology. A detailed analysis of specific flexible pipes failures was carried out. Failures, which occurred most frequently and on the highest percentage of the sewer pipe lengths were identified. The failures were classified according to the intensity of their occurrence and caused danger. Class 1 covers the greatest failures and the highest level of danger, class 5 covers minor failures with the lower level of danger. The technical condition of the investigated sewers was assessed by classifying the particular sections to one of 3 groups: G 1 – without

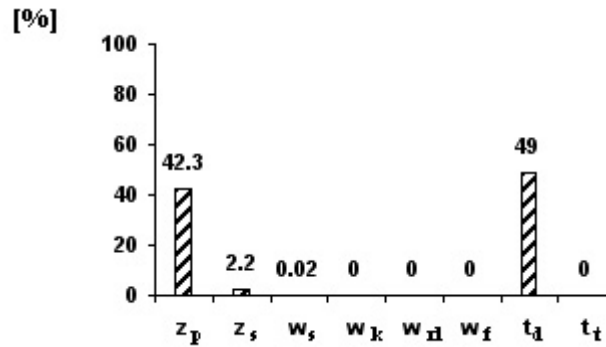
Fig. 1. The summary results of the investigation of various linear failures

As it is shown in figures, the linear failures, which occurred on the considerable length of the sewers are: the deflection of the top (49,0%), the movable sediment (42,3%) and immovable sediment (2,2%). The following figures present those failures divided into classes of intensity of their occurrence.

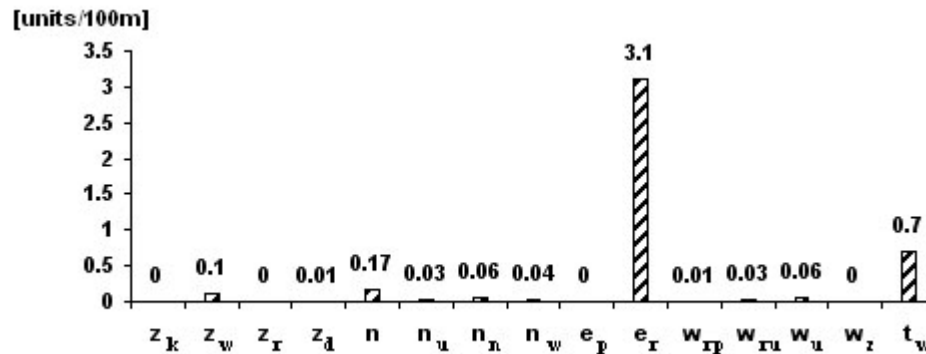
Fig. 2. The summary of the intensity of occurrence of the various point failures in units/100 m

The point failures, which occurred quite often were the longitudinal displacements, which were 3.1 piece/100m. The other failures were observed more rarely than 1 piece/100 m of the Sewer length. However, worth mentioning are: local dents 0.7 piece/100 m, infiltration 0.17 piece/100 m, Figure 6 presents the per cent share of the longitudinal displacements, which was signed by the e_r in five classes of failures. The division into classes is as follows:

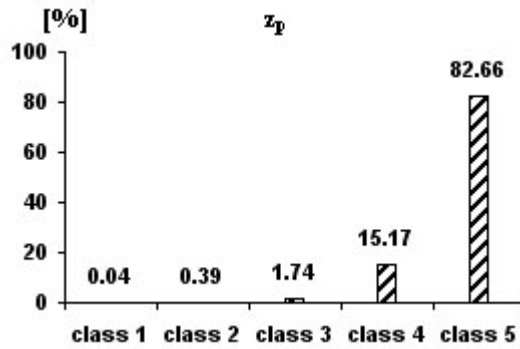
Fig. 3. The movable sediment z_p with the division into the classes of failures

Figure 3 shows the percentage fraction of the sewers length with the movable sediment with the division into classes of failures. The sediment signed by the symbol z_p and show the percentage of the occupied sewer cross section fulfills successively the condition in classes 1 to 5: $z_p \geq 50$ (class 1), $35 \leq z_p < 50$ (class 2), $20 \leq z_p < 35$ (class 3), $5 \leq z_p < 20$ (class 4), $z_p < 5$ (class 5).

The sediments in the bottom of the sewer, which come from the construction period, were connected in most cases with improper longitudinal gradient of the sewers. More than 80% of those sediments were assigned to 5th class of failures, because they occupied less than 5% of the sewer cross-section. To 4th class there was classified 15.17% of the sewer length which were occupied by the sediments, to 3rd class 1.74%, to 2nd class 0.39%, to 1st class only 0.04% of the sewer length which was occupied by the movable sediment occupying more than 50% of the sewer cross-section. Figure 10 shows the movable sediment, which was classified to 4th class of failures.

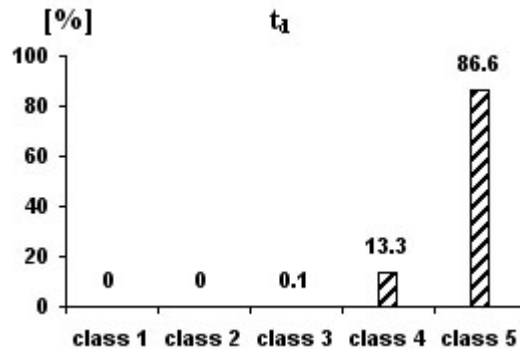
Fig. 4. The deflection of the top t_d with the division into the classes of failures

Figure 4 presents the per cent share of the sewer length with the observed deflections of the top with the division into the classes of failures. The deflection of the top is signed by the symbol t_d and expressed in per cent. It fulfills successively the condition in classes 1 to 5: $t_d \geq 40$, $25 \leq t_d < 40$, $15 \leq t_d < 25$, $6 \leq t_d < 15$, $t_d < 6$, where t_d is calculated from the equation:

The deflection of the pipe's top was observed on the considerable pipe's length. In 86.6% they were minor deflections, lower than 6%, qualified to 5th class of failures. To 4th class of failures there were classified 13.3% of the deflected pipes, where deflections were more than 6% and less than 15%. According to the proposed classification only 0.1% of the deflected pipes were classified to 3rd class. Their deflection was more than 15%. The deflection of the top of the pipe classified to the 4th class was shown in figure 12.

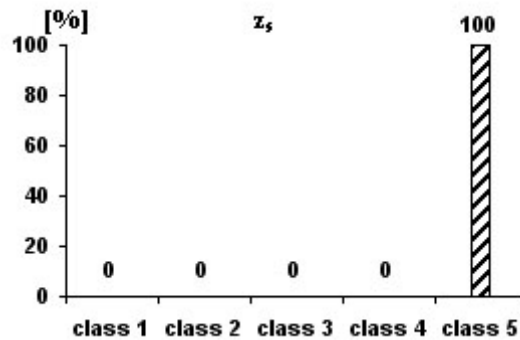
Fig 5. The immovable sediment z_s with the division into the classes of failures

Figure 5 presents the per cent share of the sewer length with the immovable sediment with the division into classes of failures. The immovable sediment signed by the symbol z_s and expressed in the percentage of the occupied sewer cross-section fulfills successively the condition in classes 1 to 5: $z_s \geq 50$, $35 \leq z_s < 50$, $20 \leq z_s < 35$, $5 \leq z_s < 20$, $z_s < 5$.

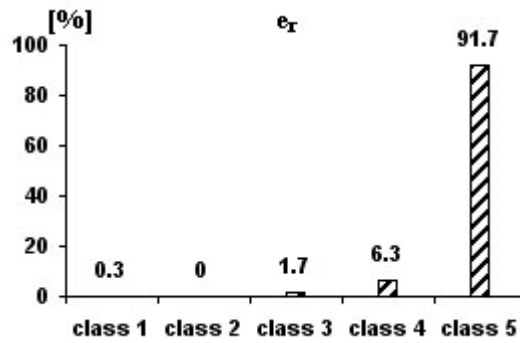
Fig. 6. The longitudinal displacements e_r with the division into the classes of failures

The point failures which were most commonly observed were: longitudinal displacements. The most of the longitudinal displacements (91.7%) was observed in the 5th class of failures. Only in one place (1st class – 0.3%) there was the direct contact of the interior of the pipe with the ground, shown in figure 13. Low one-sided longitudinal displacements (5th class) are shown in figure 14. It indicates the improper longitudinal slope.

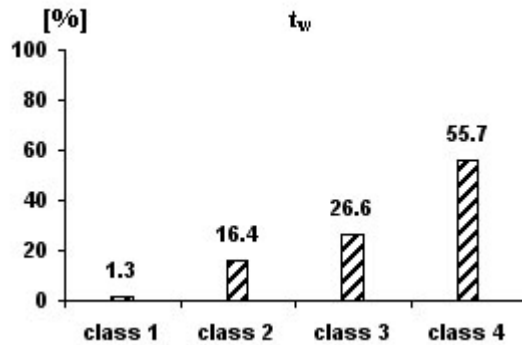
Fig. 7. The local dents t_w with the division into classes

The local dents from e.g. sharp cobblers, signed by a symbol t_w were included in four groups of failures, in which the depth of dent is measured in [mm] and equal successively: $t_w \geq 20$ (class 1), $15 \leq t_w < 20$ (class 2), $10 \leq t_w < 15$ (class 3), $t_w < 10$ (class 4). Figure 7 presents assigning the observed local dents of PVC pipes to particular classes.

More than half of the observed local dents e.g. from the cobbles were classified to the 4th class of failures. Less of the failures (26.6%) were classified to the 3rd class, much less (16.4%) were classified to the 2nd class. One dent of 1.3% was classified to 1 st class and was larger than 20 mm. The examples of the local dents are shown in figure 15.

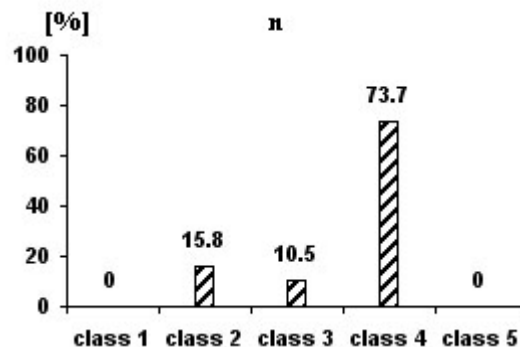
Fig. 8. Groundwater infiltration n into the Sewer interior with the division into the classes of failures

Figure 8 shows the per cent share of various groundwater infiltration cases into the sewer, signed by the symbol n , taking the following division into classes of failures:

The groundwater infiltration to the pipe interior was observed only in one city. The water dripping was observed in 73.7%, which classified this failure to the 4th class, the dribbling of the water was observed in 10.5% (3rd class), the inflow of water into the pipe interior was observed in 15.8% (class 2).

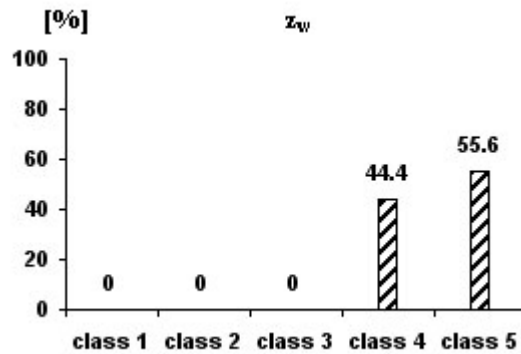
Fig. 9. House drains or sealing that jut out in the interior z_w with the division into the classes of failures

Figure 9 shows the per cent share of the observed house drains or sealing that jut out in the interior. This failure was signed by the symbol z_w and expressed in the per cent of the occupied sewer cross-section. It fulfills the following requirements, successively for classes from 1 to 5: $z_w \geq 50$ (class 1), $35 \leq z_w < 50$ (class 2), $20 \leq z_w < 35$ (class 3), $5 \leq z_w < 20$ (class 4), $z_w < 5$ (class V).

The house drains or the sealing that jut out to the interior in 55.6% occupied less than 5% of the pipe cross section and were classified to the 5th class of failures. 44% of those obstacles in the flow were classified to the 4th class, as they occupied more than 5% but less than 20% of the pipe interior. In figure 16 there is shown the house drain that juts out to the pipe's interior and unables the progress of the camera. In figure 17 there is shown the sealing which juts out of the connection.

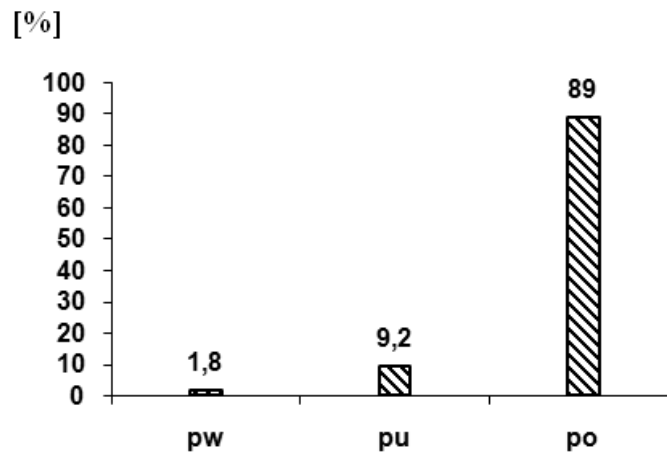
Fig. 18. The correctness of the connections: p_w – the house drains that jut out to the pipe interior, p_u – the house drains that are faulty, p_o – they correct house drains

The minor percentage of the house drains was improper: 1.8% were jutting out to the interior, 9.2% were faulty, 89% were correct. The research results involving the connections are shown in figure 18.

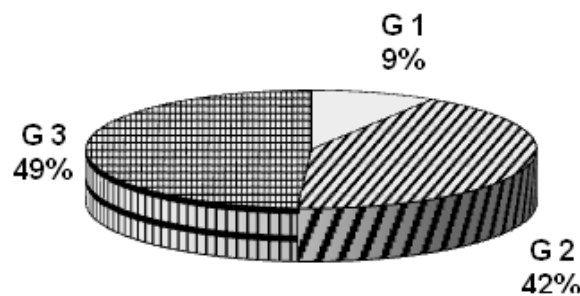
Fig. 19. The percentage of sewer sections from the groups: G 1 – without failures, G 2 – with failures in the 5th class, G 3 – with failures in classes 1 – 4

To the group G 1, that included the correct sewer sections (without any failures) there were classified only 9% of the Sewer sections. To the group G 2, that included one or several types of failures involved in the 5th class of failures there were classified 42% of the sewer sections. In case of long-exploited sewers pipes with such minor failures do not qualify to the rehabilitation. In case of the sewers newly laid in the ground it is a matter of discussion of those pipes should be taken to exploitation or not. In the standard concerning the requirements when sewer construction works acceptance should be adjusted the rules of sewer construction works acceptance for the sewers with the failures classified to the 5th class of failures. In the group G 3 there was a almost half of the sewer sections (49%), which had the larger failures, classified to classes from 1 to 4. Those sections are not qualified to the acceptance.

The analysis of the research results of sewer pipes made of PVC, which were newly laid in the ground indicates their very poor technical condition. Those sewer should be correct, without any failures. Yet, as it was shown in this paper, large percentage of them is qualified to rehabilitation or replacement prior to starting their exploitation.
