BADIDA Miroslav, Dr.h.c. prof. Ing., PhD.

UTILIZATION INFRARED THERMOGRAPHY IN THE AUTOMOTIVE INDUSTRY TO DETERMINE FAULTS BY USING THERMAL CAMERA FLUKE Ti10

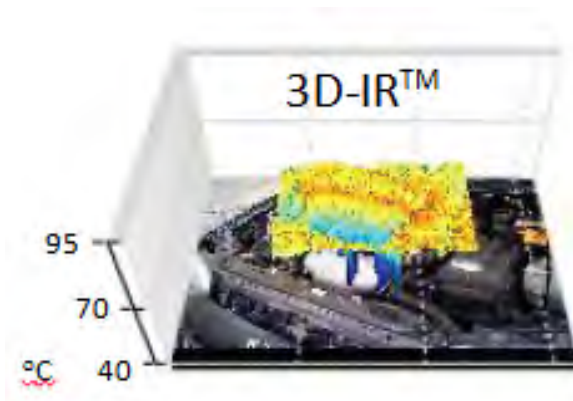
Fig. 8 Graph [3]

In the evaluation, we focused mainly on the image of fully warm engine, on which were clearly visible deficiencies. It was mainly a thermal anomaly in exhaust pipe area on 4. cylinder (Fig. 6). Due to the fact that the engine in the emission test showed increased emissions and noise from the exhaust pipe, we concluded that the problem is just the fourth cylinder on the basis of exhaust pipe infrared images, which showed a lower temperature compared to the other three pipelines under the heat shield (Fig. 7).

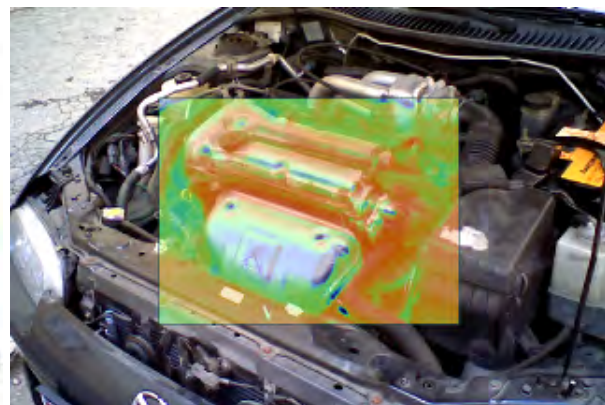
Fig. 9 IR-Image [3]

There have been two options for cooler pipe on 4. cylinder - a bad fuel injector, or bad fuel ignition. Therefore, testing of the ramp injections took place through injection nozzles and its seals because of the possible fuel leaks, or due to clogging of injection nozzles. Problem was not confirmed at this point. The next step was to test the engine compression without combustion process and engine oil analysis for the presence of fuel. Compression was standard, as specified by the manufacturer of internal combustion engine, but the oil showed a small representation of unburned gasoline. This test was done by a authorized service. [4]

Subsequently, the test moved to diagnose spark plugs and distributor. The problem arised in this area, because the primary and secondary winding of distribution coil was off the manufacturer's specified values, resulting in a poor running engine and low power, but the problem that caused the bad combustion process on the 4th cylinder was the head of the distributor with damaged pin for power supply to the ignition cable and spark plug. After replacing these parts and reset of the engine control unit, this error did not repeat, and the engine has not only improved performance, but also emission rates and combustion temperatures. [5, 9, 11]
