**THE EFFECT OF INACCURACIES OF THE AUXILIARY SENSORS
IN THE COURSE OF DATA PROCESSING OF MULTIBEAM SURVEY**

V. Dvoretzky

National University «Odessa Maritime Academy»

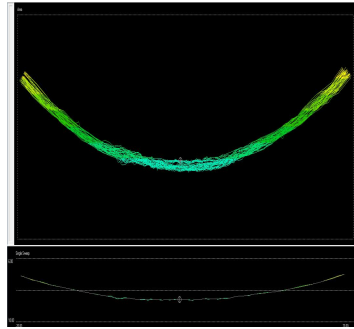
As a result, an error in the ray tracing will lead to a banded bottom profile. Such artifact is easy to detect when looking at the cross section profile over the flat bottom. If there is a «smile» in the profile it is an evidence of sound velocity artifacts in the data (figure 2 and 3).

Figure 2. Increased SV

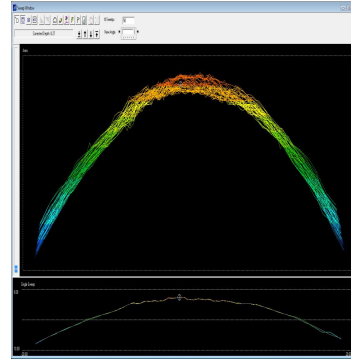
Figure 3. Decreased SV

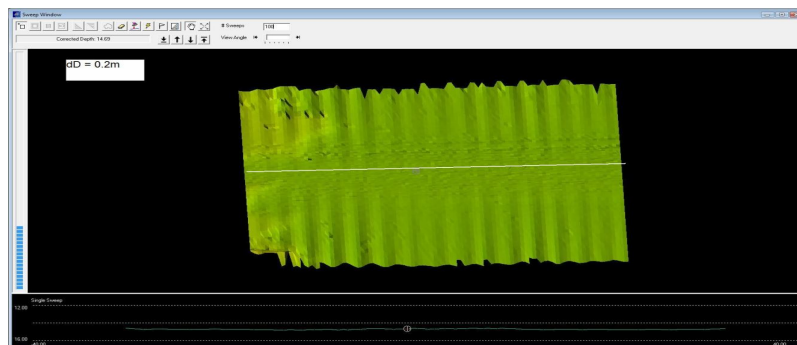
Such artifact is easy to detect on a flat bottom if you see asynchronous waves on the sides of the track as shown in the figure 6.

Figure 6. Roll Artifact

2. Bad roll data from MRU or no roll data at all.

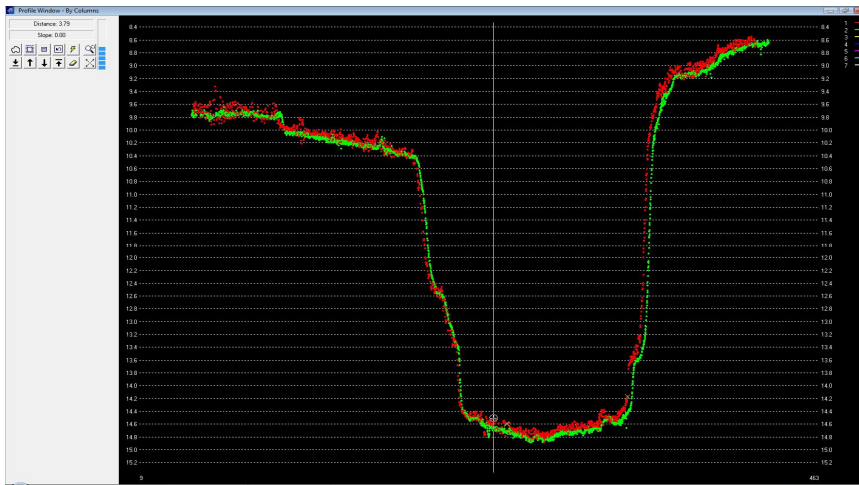
If there is latency in the data it can lead to a shift of the real slope. It is easy to detect if you overlay two along track profiles made across the slope in the same direction but with different speed (MBE) or in opposite directions with the same speed (SBE). Figure 7 shows the latency of 1s leads to almost 3.5m shift of the slope at a depth of 8-15 m.

Figure 7. Profile view of the two datasets with the latency artifact along the track across the channel in HYSWEEP Editor

Latency Artifacts. There is some time delay between the moment when a GPS has found the position and the moment this data arrives to a computer that is called latency.

The best way to determine the latency is to perform the Patch Test.
