QUALITY ASSURANCE FOR REINFORCED CONCRETE CONSTRUCTION RENOVATION

For the analysis of the indicated problem there is a good reason to consider the example of repair and restoration works execution while under reconstruction of the National Sports Complex "Olimpiysky" in Kiev. Works were performed prior to the 14th European Football Championship 2012 (UEFA Euro 2012).

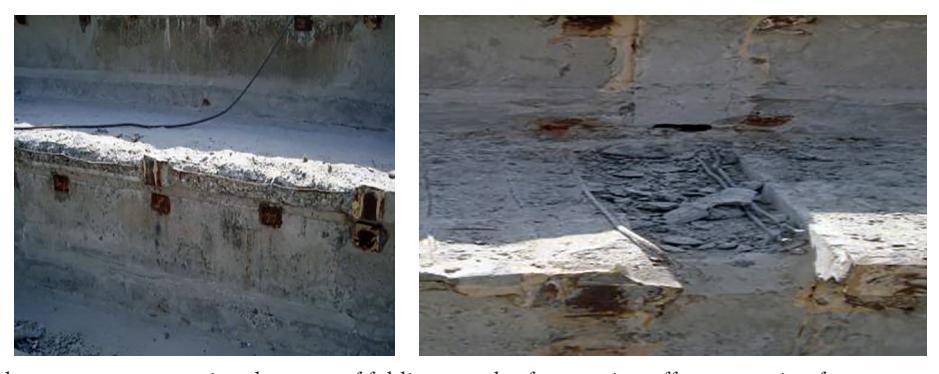
Fig. 1. Reinforced concrete construction damages of folding panels after cutting off encrustation from concrete repair mortars

Due to continuous exploitation cohesion strength of the specified constructions ranged from 0.5 to 3 MPa, salinity level on some sites was high and compression capacity was 15–50 MPa. Cavities, spalls and pots including ones with reinforcement exposures within folding panels were detected.

During the panels inspection significant surface damages of folding panels used for upper circle of stadium stands were found. Damages were represented by concrete cover liftings, reinforcement exposures and partial damages of concrete, Fig.1. Cohesion strength of the specified constructions ranged from 0.5 to 3 MPa and compression capacity ranged from 15 to 50 MPa.Lifting of covers that have been provided on repair and reconstruction purposes were detected. It was found that the preceding repairs of folding panel coverings had been executing in 1966–1991 period. Cement-sand, concrete and bituminous concrete

Based on the results of conducted diagnosis the author of this publication proposed execution of folding panel construction renovation using the advanced produced domestically aggregates as a solution. It was considered to demolish damaged construction coverings at first with the following reconstruction using the advanced materials. Experts from Scientific Research Institute of Building Constructions (SPIBC) and Scientific Research Institute of Construction Manufacturing (SRIBM) were also involved in development and approval of decisions on construction renovation. System of repair materials CERESIT PCC produced by "Henkel Bautechnik" (Ukraine) was agreed for usage. This system contains such key products as mineral single-component and rust-preventing filler Ceresit CD30²⁰¹², which is also used for contact (adhesional) layer covering and polymer cement coarse-grained aggregate for repair and restoration

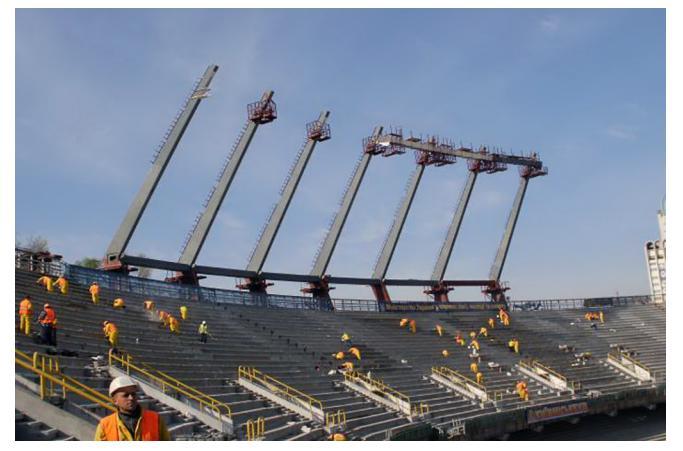
Fig. 2. Relative workzone divisioning for repaired structures

Works on folding panel reconstruction were executed in the following technological order. At the first stage there was a pre-construction with relative repaired structure divisioning and creation of safe and lean working conditions, Fig.2. Then, the following operations were executed: concrete surfaces shaping with diamond face milling cutters, beating with kango hammer damaged concrete from out the folding panel overhangs on the horizontal surfaces of folding panels (till the depth will reach no less than 20 MPa where strong concrete is located), dedusting the surface using industrial vacuum cleaners and reinforcement cleaning using wire brushes till St2 preparation grade as well as reconnection of bar reinforcement of reinforcing steel net using tying wire. After repair and restoration of folding panel overhangs of reinforced concrete constructions with the necessary exposed and already cleaned reinforcing bars covering with anticorrosive aggregate and with subsequent panel geometry reconstruction through filling polymer cement aggregate for repair into a non-prefabricated form were executed. According to the preliminary specifications repair and restoration works were followed by laying as creed on the horizontal panel surface containing presizing operations, covering adhesional layer with alkali-resistant grid reinforcement, laying as creed using coarse-grained aggregate for repair on the surfaces. Vertical surfaces of folding panels were repaired (in the absence of considerable damages) using polymer-cement spackle with a layer thickness up to 5 mm.

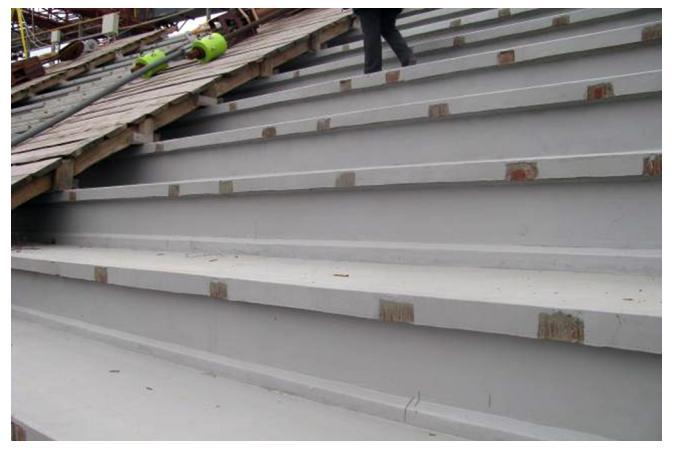
Fig. 3. Folding panel appearance after finishing repair and restoration works

Order represented in Table 1 and well-defined materials allowed to execute works on the proper quality level. After repair and restoration works had been finished folding panels obtained design condition, Fig.3. The important work execution element is quality control reflection in the operating construction documents [4, p. 23, 5, p.

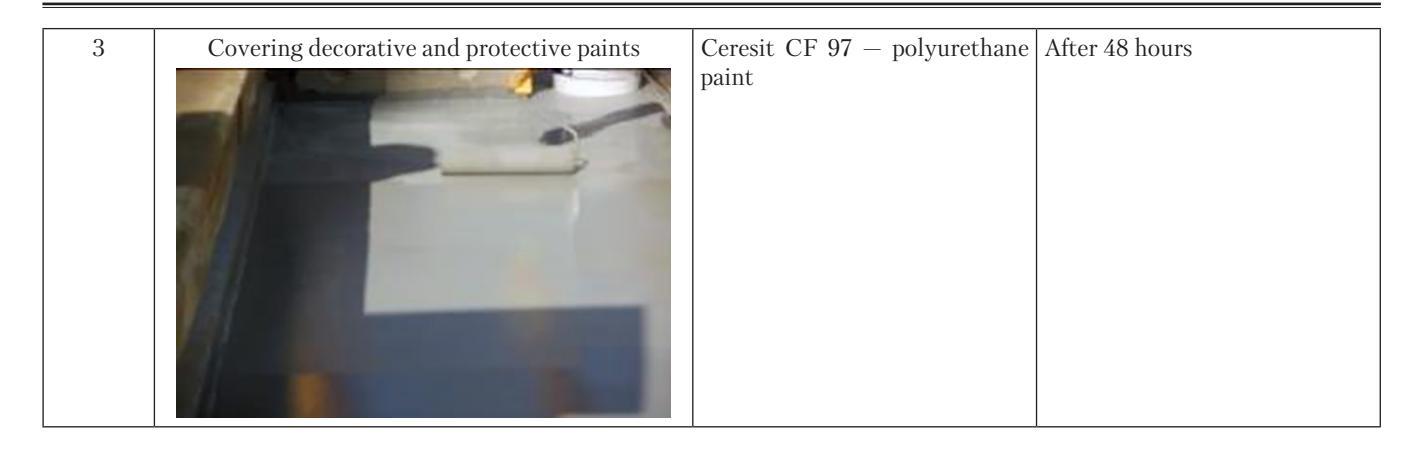
Item No.	Process name and its visualization	Used materials	Building regulations
1	2	3	4
•	1. Geometry design re	construction of folding panel	•
1	Surface clearing and reinforcement cleaning		
2	Form erection	Non-prefabricated form

3	Covering reinforcement and concrete surface with anticorrosive and claying mixture	Anticorrosive and claying mix- ture Ceresit CD30 ²⁰¹² "2 in 1"	after reinforcement cleaning
4	Placing aggregate for repair	Aggregate for repair Ceresit CD22 ²⁰¹² with the addition of elastic emulsion Ceresit CC 83	Covered after partial drying out of contact layer, in 30–60 min- utes
5	Vertical surface alignment using spackle	Polymer-cement spackle Cere- sit CD24	In 48 hours after works com- pleted
	2. Laying a se	creed using strips	
1	Sizing	Thomsit R766 — multifunction- al acrylic primer	After 3 days

2	Covering with adhesive layer	Adhesive layer Ceresit CD22 ²⁰¹² + Thomsit R766 — reinforced with alkali-resistant fibreglass mesh with the thick- ness of 4 mm	primer
3	Laying a screed	CD22 ²⁰¹²	Immediately after coating with adhesive layer
	3. Decorative an	d protective coating	
1	Covering surface with epoxy primer and subse- quent quartz sanding	Ceresit CF 87-epoxy primer	After complete drying out of the aggregate
2	Polyurethane coating	Ceresit CF 91 — Polyurethane composition,	After 24 hours
