*Oleh Rybchynskyi*

## PROBLEMS OF RESTORATION OF NATURAL STONE MONUMENTS LOCATED IN THE CITY PARKS

*Lviv Polytechnic National University  
12, Bandery Str., 12, 79013 Lviv, Ukraine, zoroleh@gmail.com*

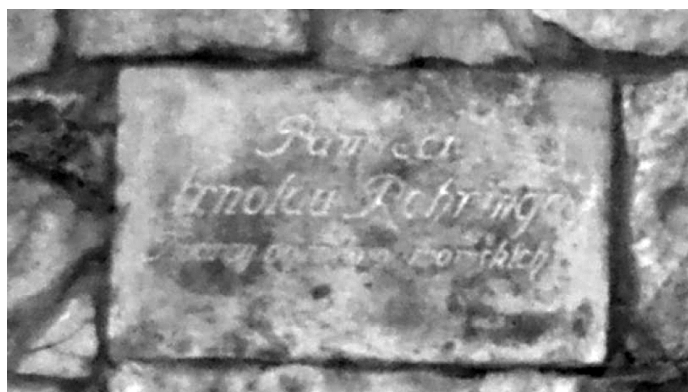
In spring 2016 restoration works of the memorial plate of Arnold Röhring in the Stryiskyj park were conducted. The monument was in a poor condition. A visual inspection of it showed a solid cement layer over the plate, absence of several letters in the main inscription and some unclear letters in the auxiliary text on the plate (Fig. 1).

**Fig. 1.** The memorial table before restoration.  
Photo by the author

Before starting restoration works a restoration program was worked out:

1. Preliminary examination;
2. Diagnosis status and material of monument;
3. Conducting conservation work;
4. Structural strengthening of monument;
5. Implementation of local reconstruction;
6. Expressiveness of forms and details of monument;
7. Implementation of glazing;
8. Blocking the cement inserts and putty.

1. Water and dry cleaning of the surface of volatile contaminants;
2. Steam cleaning of the surface from sustainable chemical, biological and atmospheric formations affecting the monument surface;
3. Chemical cleaning of the surface from persistent pollutants;
4. Removal of later aggressive and cement inserts;
5. Filling-in of cracks and caverns with selected materials;
6. Implementing of additions to lost fragments with compatible materials;

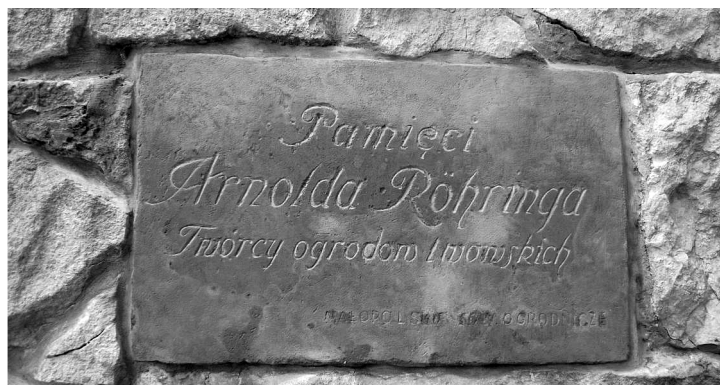
As a result of the undertaken restoration works, the surface cement coverage of the slab has been taken off, additions of the damaged parts have been made, the lost letter inscription was restored, as well as the auxiliary inscriptions (Małopolskie Tow. Ogrodnicze). 60 % of the surface plates have been restored. Also, the filling-in of edges around the plate's perimeter was done to protect it from excess moisture that comes through the capillaries of the spring. (Fig. 2) After the clearing the memorial plate got back its authentic dark-ocher color.

**Fig. 2.** Memorial plate after restoration. Photo by the author

As the next stage of repair works, a thorough restoration of the wall to which is fixed the memorial plate must be carried out. It requires the applying of waterproof barrier, restoration of authentic relief composition, etc.
