PROTECTING BIRDS AND BATS IN BUILDINGS UNDERGOING THERMAL INSULATION IMPROVEMENTS – PROCEDURES AND PRACTICE IN POLAND

Karolina Jamska

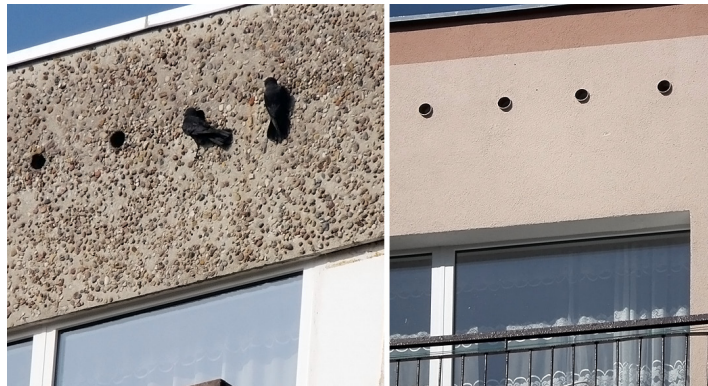
Fig. 1. Inlet tubes installed in the roof structure inhabited by Jackdaws should provide an easy access to the birds' habitat after the renovation - in this building (left – before renovation; right – after renovation) the Jackdaws lost their habitat due to the installation of smaller diameter tubes than the recommended 93 mm

LEAVING HABITATS INTACT. The best compensating solution is to leave any holes and cavities, which were previously occupied by birds and bats, open [20]. This solution is now most commonly used in situations where birds occupy roof vent openings. During the building renovation, these openings are furnished with either ceramic or PVC extension tubes [13]. It is an inexpensive, most durable, while at the same time the best solution. Animals do not need to get accustomed to the new conditions, and the risk they leave their habitat is minimized. It is important, however, that these inlet tubes have rugged inner surfaces so the birds will not slip inside them and have an appropriate diameter for the various species. This solution is currently used mostly for Common Swift (tubes with a diameter of 50–80 mm) and Jackdaw. The nesting boxes recommended for Jackdaw have entry holes with a diameter of minimum of 80 mm (usually 85 mm) [19]. However, my preliminary observations show that these birds, which are strongly attached to their habitats [19], leave their former dwellings in the buildings where during the renovation the entry tubes of such a small size have been installed. So most likely a diameter of 80 or even 85 mm is too small in situations where the pathway for these birds has been increased from just a few cm as in the nesting boxes to tens of centimeters travelled inside the tubes in the renovated buildings. Therefore, the safest option for Jackdaw is to install inlet tubes with a larger diameter of 100 mm. This would not only provide an easier access to the bird's nesting sites, but would also minimize the negative effects of potential contractor's errors when the installed tubes are a few millimeters smaller than the recommended by RDEP. Such errors have been reported in Bydgoszcz several times already and while the renovation work appeared to comply with the required guidelines in the end the birds have lost their habitat (Fig. 1).

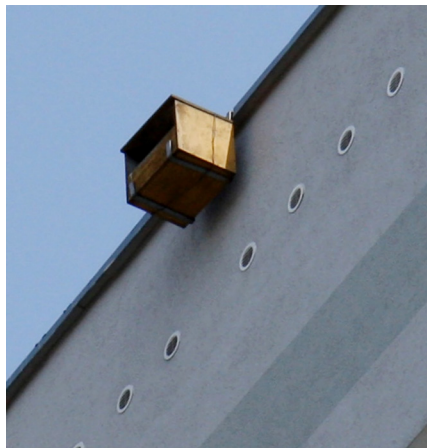
Fig. 2. Wooden nesting box for Kestrel suspended from the building roof as a part of compensation project

NESTING BOXES. Leaving the animal habitats intact is not always possible. This is especially true in situations where wall cracks or crevices which are either hard to reach or threaten the durability and integrity of the building structure must be filled thus resulting in the destruction of animal habitat. Installation of nesting boxes for birds and bats is the most common method of compensation for destroyed habitats in buildings [22]. This solution is a compromise between what is best for animals and the building owner's reluctance toward the "wildlife squatters". Nesting boxes are more expensive to install and less beneficial for birds and bats. Animals must get accustomed to a new place, the box material and limited space, so it happens that they leave their previously used long term habitats. Wooden boxes (Fig. 2) are relatively inexpensive, but have little resistance to

external weather conditions, and therefore they need to be replaced every few years. To delay the decay process the wood material should be impregnated with a suitable and non-toxic solution, and the box roofs covered with asphalt shingles or sheet metal [27].

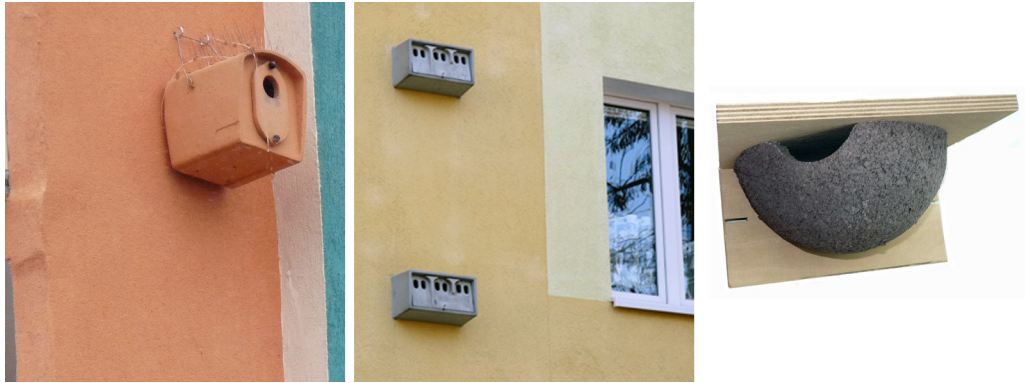
Fig. 3, 4 and 5. Sawdust concrete nesting boxes for Jackdaw (left), Sparrow (center) and House Martin (right)

It is important to ensure the boxes for bats provide a good grip on all of their internal and external surfaces such as through the use of not planed, rugged and rough wood. Sawdust concrete boxes (Fig. 3, 4 and 5) are more durable than wooden boxes, but several times more expensive.

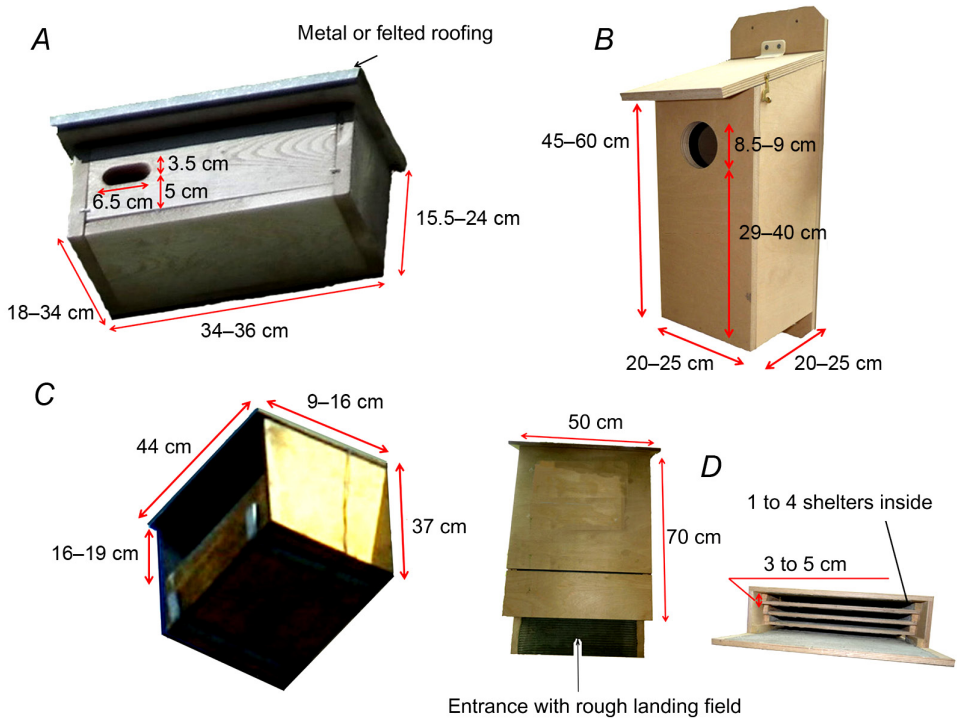
Fig. 6. Examples of wooden nesting boxes with dimensions. Used for: A – Swifts, B – Jackdaws, C – Kestrels, D – Bats

All nesting boxes incur additional maintenance costs as they require periodic cleaning. Due to their relatively small capacity they quickly fill up with nesting materials, the remains of dead animals or other litter which has to be periodically removed. There are different types of nesting boxes for each species or groups of species (Fig. 6). The boxes differ primarily in the dimensions of their inlets, for example for Swift the inlet dimensions are 3.5 cm × 6.5 cm, 8– 9 cm for Jackdaw, 16– 19 cm × 40 cm for Kestrel, 3.3 cm for Sparrow [12], the gap height of 3–5 cm for bats 2008 [27].

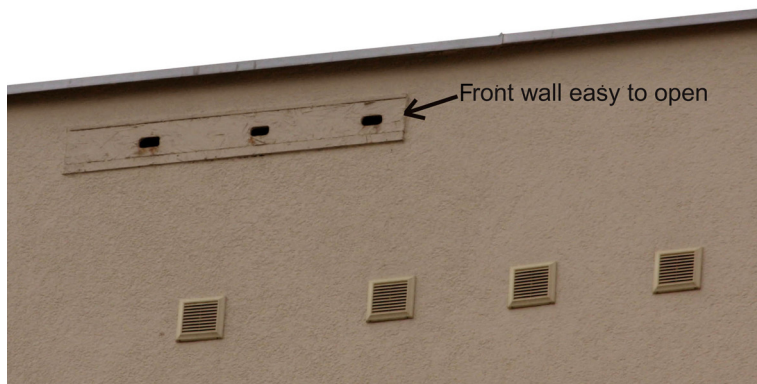
Fig. 7. Example of well planned compensation for bats and birds on the building's wall

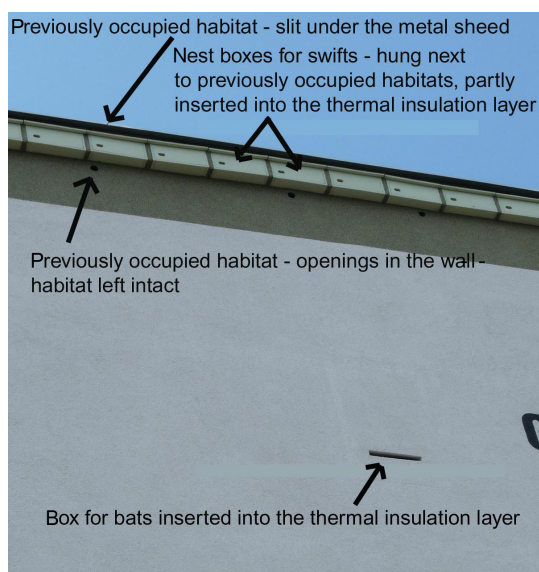
Fig. 8. Nesting boxes for Swift inserted into thermal insulation layer. Removable front partition allows for periodic cleaning of nesting boxes

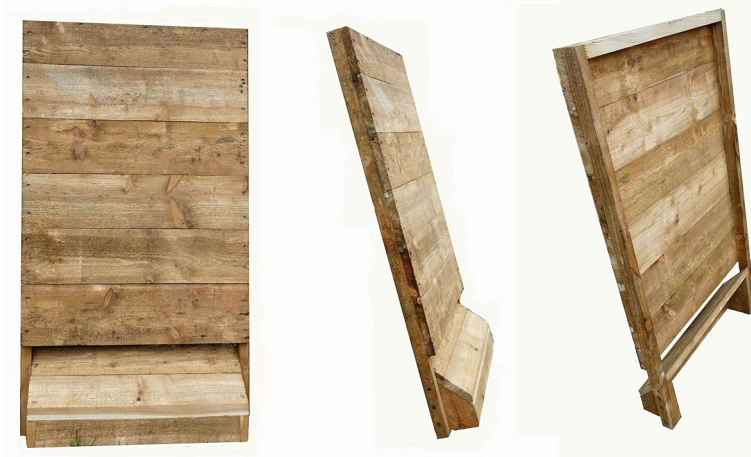
Fig. 9. Self-cleaning box for bats for insertion into thermal insulation layer: front (left), side (center), back (right)

Boxes for individual species are mounted at different minimum heights, for example: for Sparrow at 3 m, for Jackdaw at 5 m, for Kestrel at 15 m, for Swift at 5 m [12]. It is also important to maintain appropriate density of installed boxes. For animals that live in colonies such as sparrows and swifts the nesting boxes can hang in groups next to each other, and for territorial birds such as kestrel, individually. Care should also be exercised to avoid the installation of nesting boxes in their close proximity for predators and their prey such as Kestrels and Sparrow [27]. To increase the likelihood of settlement, the nesting boxes should be installed as close to the animals' previously occupied habitat as practically possible (Fig. 7). They can be hung directly on a newly insulated building wall or inserted into the thermal insulation layer (Fig. 7, 8). The second installation method is more aesthetic and provides greater durability [15, 27]. It also provides thermal conditions suitable for hibernating bats. However with this installation method, means should be provided to open the bird nesting boxes for a periodic cleaning while the bat boxes should be fitted with ramps to facilitate their self-cleaning (Fig. 9).

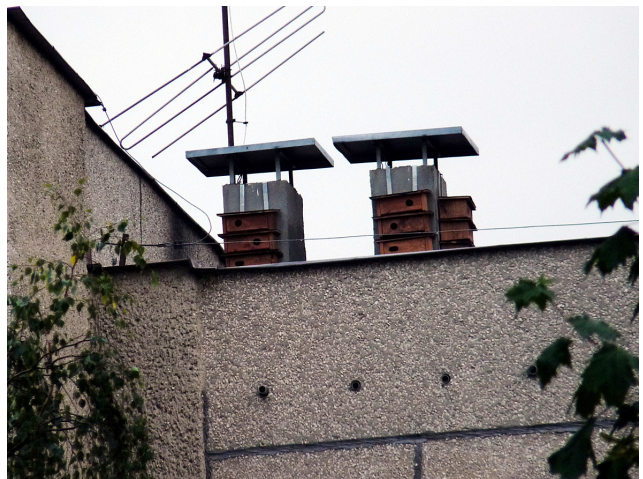
Fig. 10. Nesting boxes for swifts hung too low above the roof. There is no chance on their inhabiting by swifts
